Case Study

Hill Croft College nursery

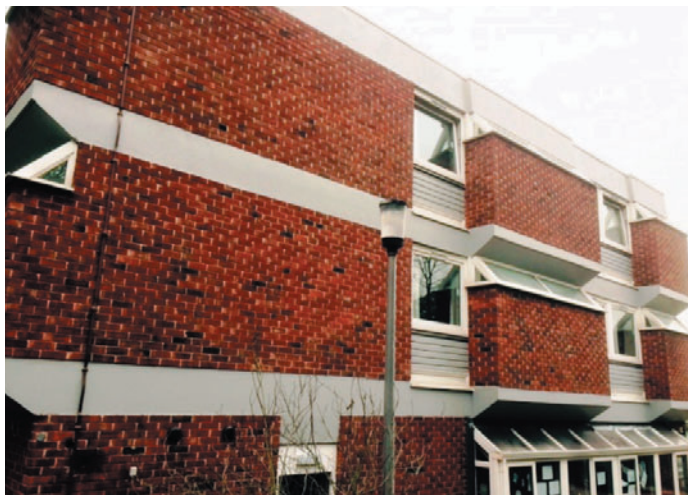
Following a survey by Cemplas it was found the building was showing signs of spalled and cracked concrete with visible corroded steel reinforcement, and a quotation and proposal was submitted to repair the concrete and apply a specialist coating to the concrete elements of the structure using Weber repair systems.

The defective areas of concrete were broken out back to sound substrates and all steel reinforcement was cleaned and treated with Weber Keycoat rust inhibiting primer. All areas of substrate concrete were primed with Weber Keycoat bonding slurry prior to the application of the repair mortars. Defective concrete was reinstated using Weber HB lightweight repair mortars, followed by the application of two coats of Weber cote smooth anti-carbonation coating.
