Case Study

Ravensroost, Upper Norwood

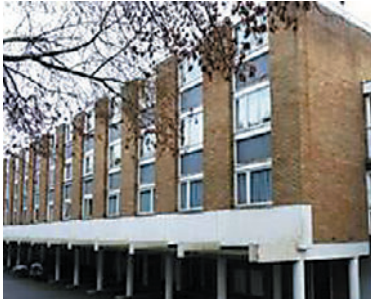
Soffit repair

In this instance, the first area undertaken was the laundry area, and following a survey and extensive hammer testing to all soffit areas by Cemplas operatives, the laundry area was found to have many defective and spalled areas of concrete. The remedial

measures proposed by Cemplas were to carry out to determine the extent of repairs. The soffit was jet washed, concrete repairs were undertaken

and two full coats of coats of anti-carbonation coatings was applied to provide a decorative and protective finish.

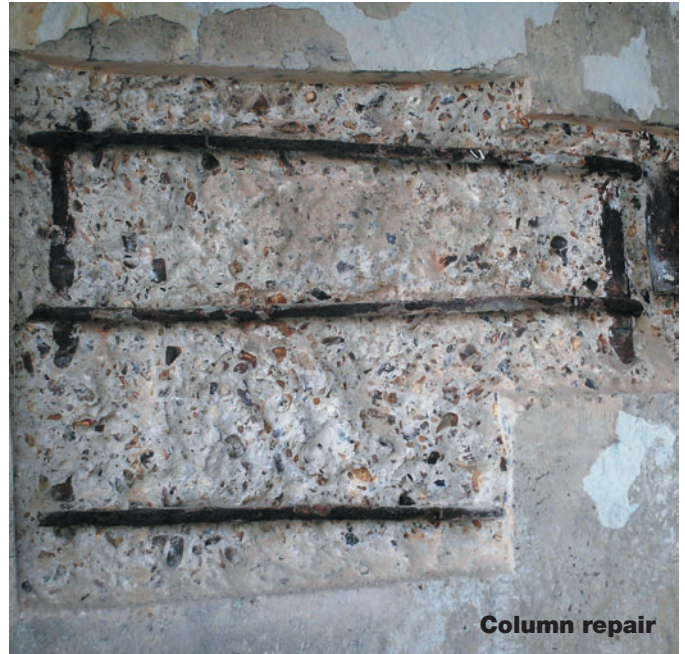
Column repair

The second area was the front elevation where a survey revealed areas of defective concrete to the buildings columns and beams. These were repaired using a polymer modified concrete repair mortar and applicable primer, and ensuring breaking behind the steel reinforcement and applying a protective rust inhibitor.
