Case Study

Royal Alexandra & Albert School

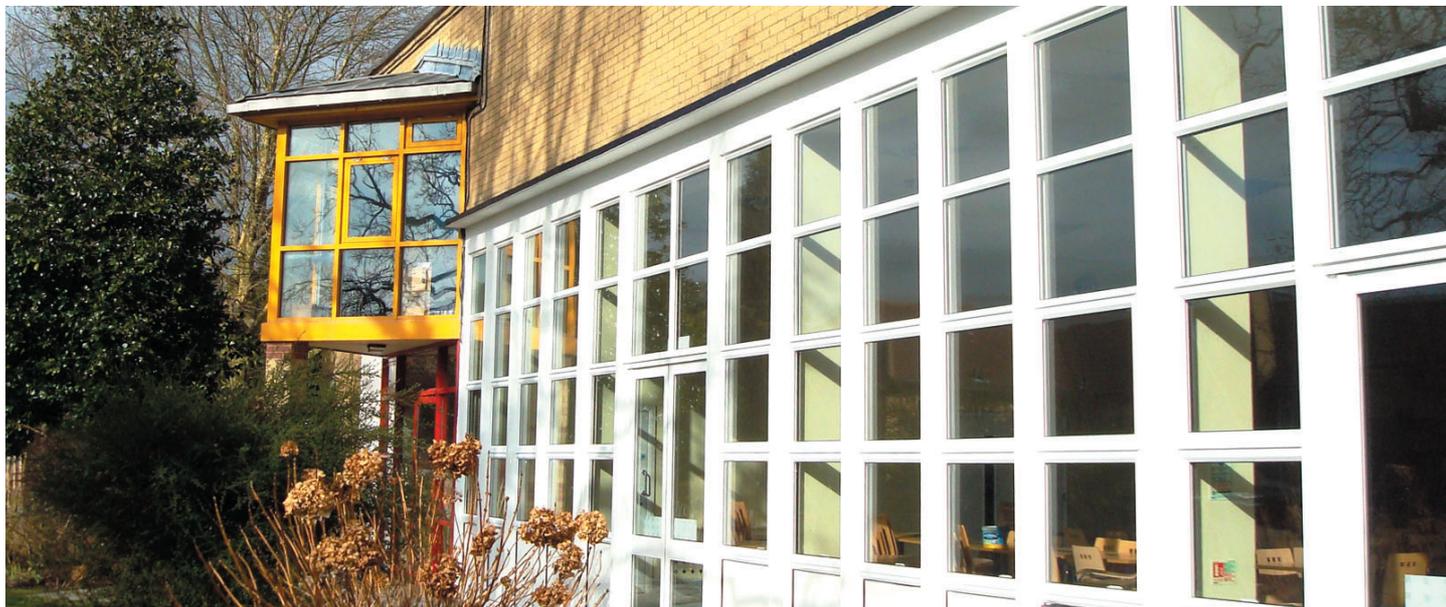
Cemplas surveyors found the concrete was carbonated resulting in localised areas of the concrete spalling and the masonry coating was also in very poor condition and delaminating from the concrete. Cemplas surveyors also found that poor detailing of the lead flashing was allowing water to penetrate and ingress the top beam of the window surrounds causing the concrete to spall.

The existing lead flashing was removed to the top of window surround and the substrate thoroughly cleaned prior to applying two coats of RIW Heaviseal specialist waterproof liquid membrane to provide a seamless, waterproof finish which would prevent any future water ingress and

As part of the remedial works Cemplas allowed for an up-stand detail between the concrete and the brickwork to provide a full waterproof angle detail and all defective concrete was broken out. Steel reinforcement bars were cleaned and treated with Sika Monotop 610 rust inhibitor to protect the steels against future corrosion and the broken out concrete was reinstated using Sika Monotop 615 high build polymer modified concrete repair mortar. Any other minor undulations to the concrete were treated to provide a smooth sound substrate on which to apply the new protective coating.

On completion of all repairs and preparation, to improve adhesion to the substrate Sikagard Primer was applied prior to applying two full coats of Sika Elastocolor 675W protective/decorative anti-carbonation coating.
