External Staircase Refurbishment

Serious Fraud Squad HQ

Case Study // Concrete Repair & Protection

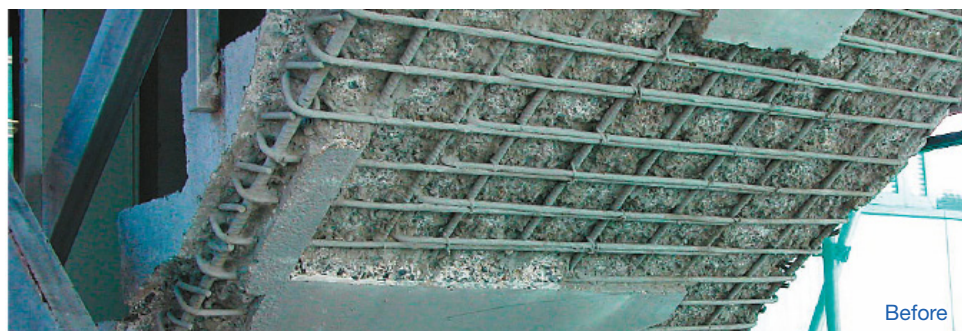
Before

Due to Health and safety issues, major concrete repairs were required to the dilapidated in-situ concrete external staircase of this 1960s building which were found to have large areas of spalling concrete falling away, and steel landings which were heavily corroded and deemed unsafe.

Repair areas were identified and then treated including undertaking hand placed repairs; an overall levelling coat was applied followed by two coats of anti-

carbonation protective treatment. All works were undertaken using the Sika Monotop Repair System.

The areas of the staircase which were manufactured in steel, and identified by the Engineer as being corroded beyond repair, required Cemplas replacing a number of the steps, and welding into position new landings. All other areas of steel were shot blasted, then primed and coated using zinc rich protective coatings including the handrails from top to bottom, and any missing or damaged bolts were replaced.
