## Office Roof Re-Waterproofing

Building 800, Kent Science Park

# Case Study // Roofing

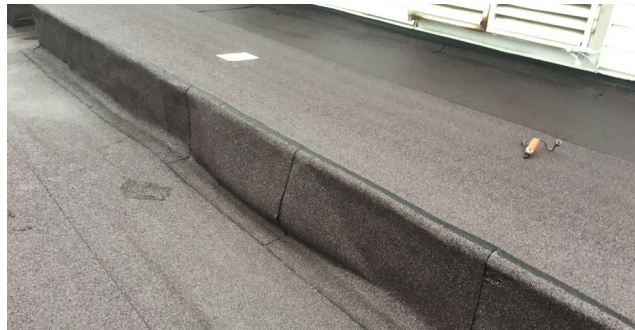
**Before:** Outgassing Blisters

The existing mineral felt membrane was both damaged and had a series of leaks via the failed lap joints. Outgassing blisters also required repair on the upper plant roof. Following these localised repairs, Kemper's V210

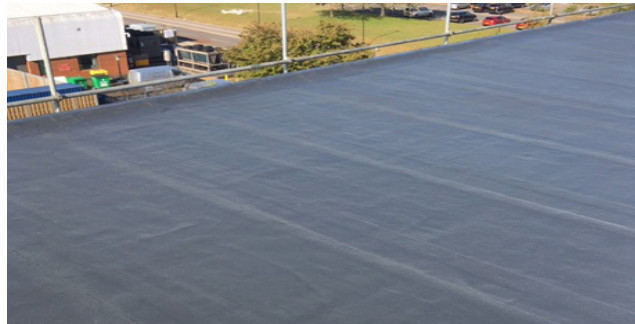
**After:** Cold, Liquid-Applied Application

**The scope of this warm-roof refurbishment was to re-waterproof the existing leaking mineral felt roof covering including localised blister repairs.**

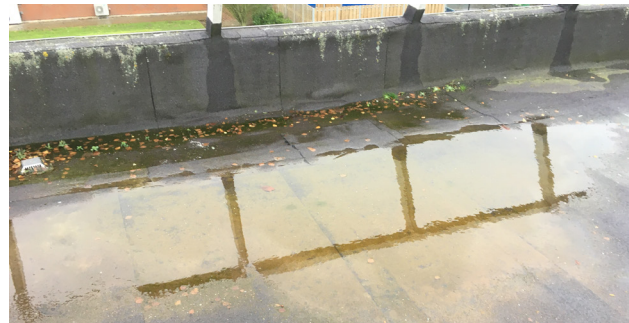
**Before:** Ponding Issues

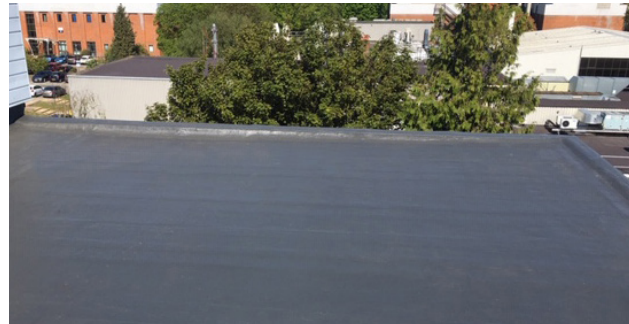
**After:** Watertight Overlay of Roof

Waterproofing system was installed with a 50mm insulation over the existing repaired membrane on both the upper plant room roof and the main roof totalling some 2,000m<sup>2</sup>.

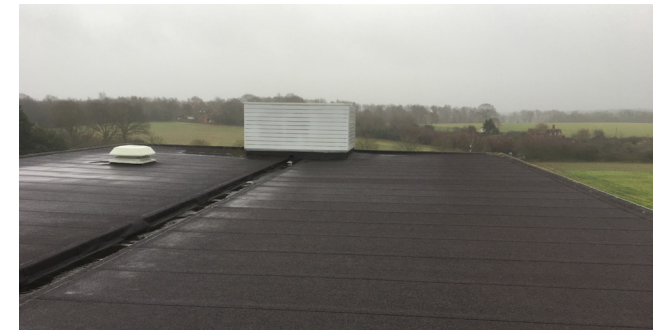
**Before:** Failed Existing Mineral Felt Roof

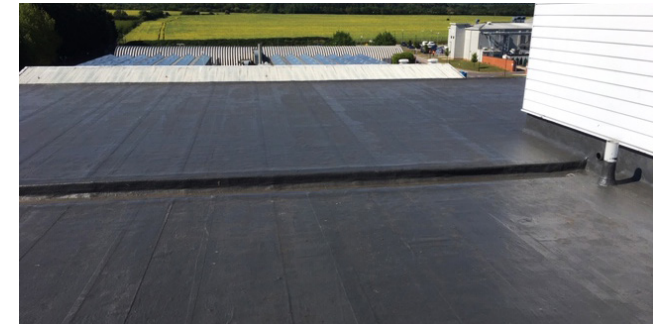
**After:** 100% Seamless & Watertight Application
