Office Roof Re-Waterproofing

Building 800, Kent Science Park

// Liquid-Applied Roof Re-waterproofing

Case Study // Roofing

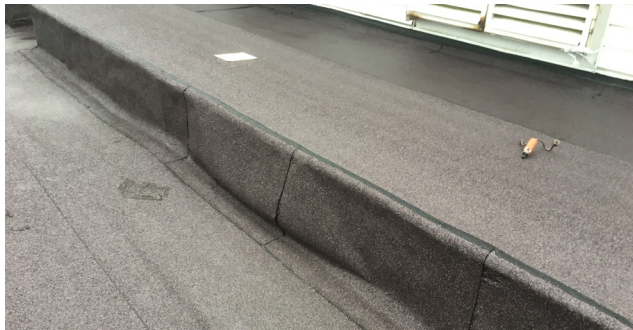
Before: Outgassing Blisters

The existing mineral felt membrane was both damaged and had a series of leaks via the failed lap joints. Outgassing blisters also required repair on the upper plant roof. Following these localised repairs, Kemper's V210

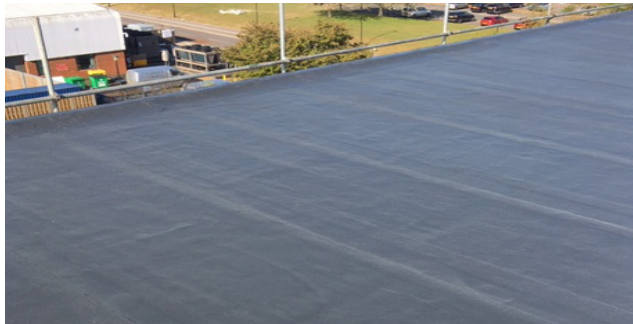
After: Cold, Liquid-Applied Application

Waterproofing system was installed with a 50mm insulation over the existing repaired membrane on both the upper plant room roof and the main roof totalling some 2,000m².

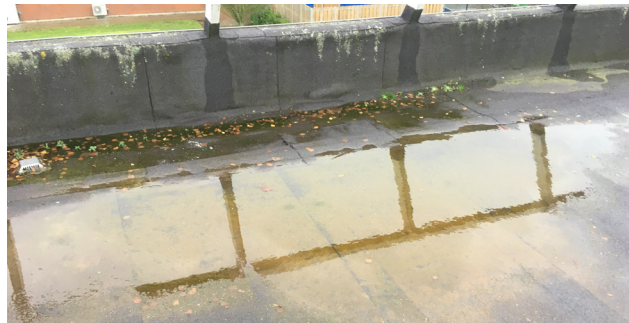
Before: Ponding Issues

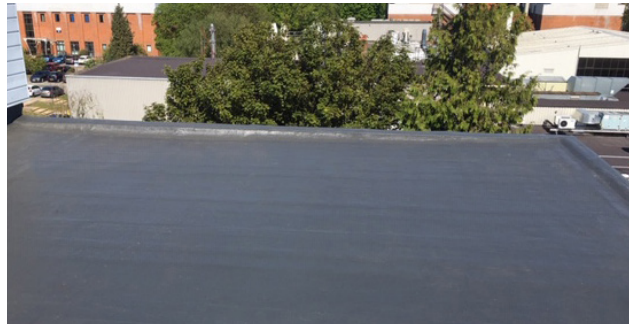
After: Watertight Overlay of Roof

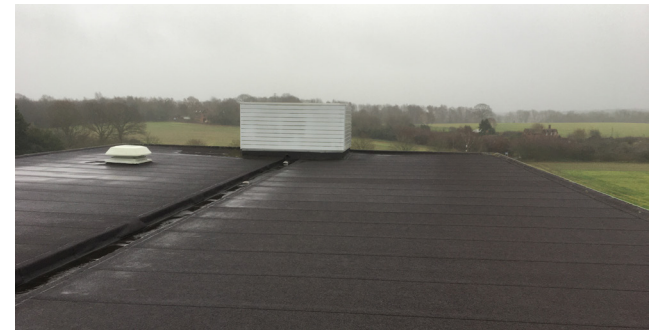
Before: Failed Existing Mineral Felt Roof

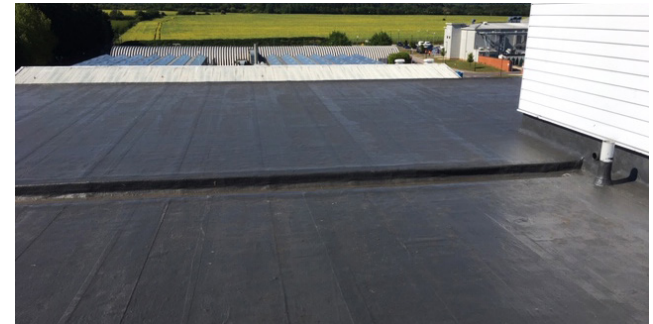
After: 100% Seamless & Watertight Application
