Case Study Repair and Protection

Client | Kier Construction
Role | Specialist Sub-Contractor

## Case Study Concrete Repair and Protection

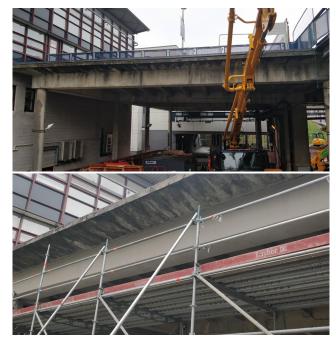
**Before:** Structurally Unsound Beams

Upon completing a non-intrusive cover meter survey and a carbonation test; it was discovered that the second beam – which would endure heavy use – required

strengthening to support the loads. The results showed noteworthy corrosion to the existing footbridge while the columns demonstrated steel corrosion and delamination of the concrete. To reinforce the steel a corrosion-inhibiting protective mortar was utilized before the concrete could be repaired.

After: Fully Protected Beams

strength carbon fibre fabric – to the 14LM of beams and columns to strengthen and reinforce them. A 2mm coat of Mapelastic Guard was applied to all surfaces to provide effective anti-carbonation and anti-corrosive protection to the structural elements.

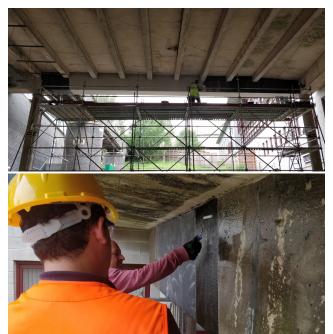
Before: Beams and Columns Unprotected

**During:** Application of Mapeband

This was followed the installation of Mapeband – a high-
