Office Roof Re-waterproofing

Commonwealth War Graves Commission, Head Office

Case Study // Roofing

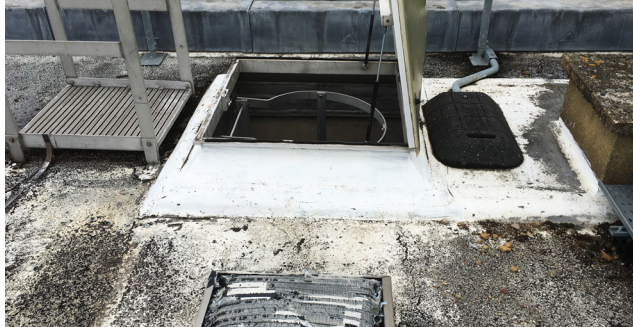
Before: Leaking Entrance Hatch

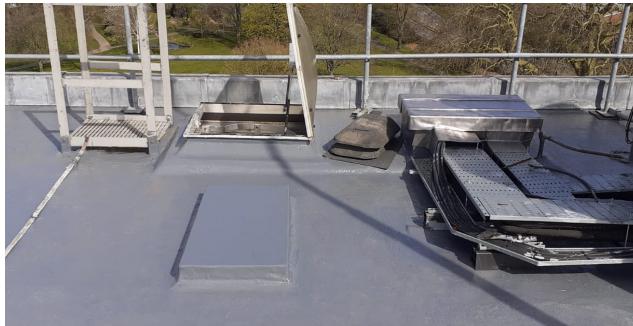
After: Entrance Hatch Watertight

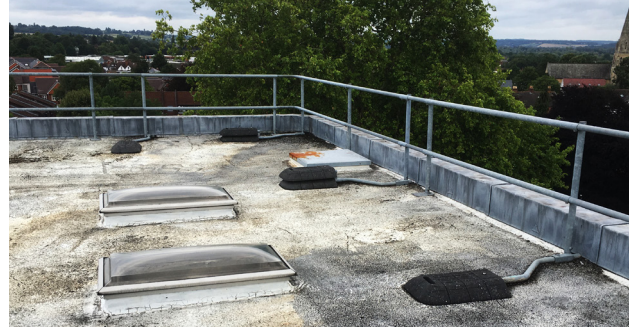
Before: Redundant Rooflights

Also included in our package of works was the removal of the four redundant rooflights which had to be capped off and secured before the waterproofing system could be

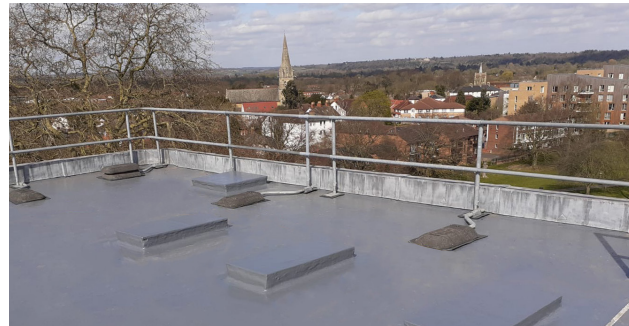
After: Rooflight Capped Off

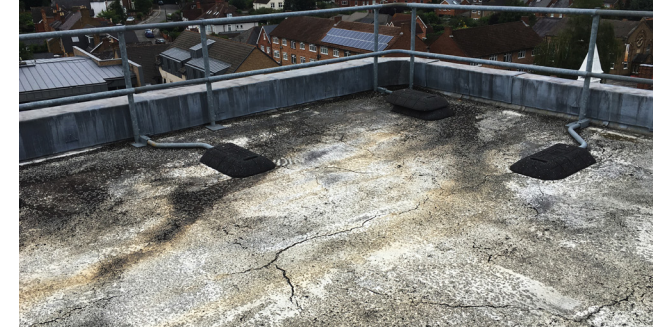
The existing asphalt waterproofing was badly aged-damaged with cracks and splits allowing water ingress into the commercial office building below. Following localised repairs to the substrate, the asphalt was prepared

Before: Split & Damaged Asphalt

by mechanical abrasion and jet washing ready for the application of Sika's Decothane Ultra roof waterproofing system, reinforced with fleece to 350m² to ensure the roof, upstands and walkways became watertight.

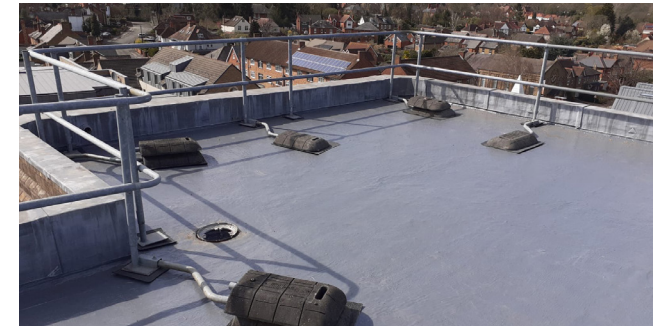
After: Seamless & Now Watertight Application
