Walkway Waterproofing

Gladstone Street, Glossop

Case Study // Social Housing

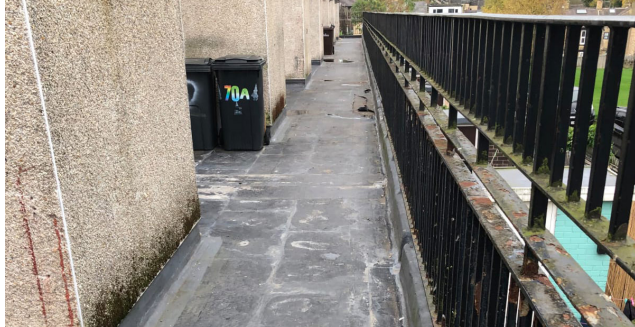
Before: Cracked & Failed Asphalt

Previously, the stairs & walkways of the structure were patch repaired which subsequently failed. It became noticeable that the existing asphalt waterproofing had reached the end of its serviceable life and required replacing. Following the stripping of the asphalt back to the original concrete slab which required minor concrete repairs. The removal of the existing railings caused damage

The scope of this refurbishment was to add longevity and re-waterproof the first-floor walkways of the structure while working to resolve historic leaks due to water ingress.

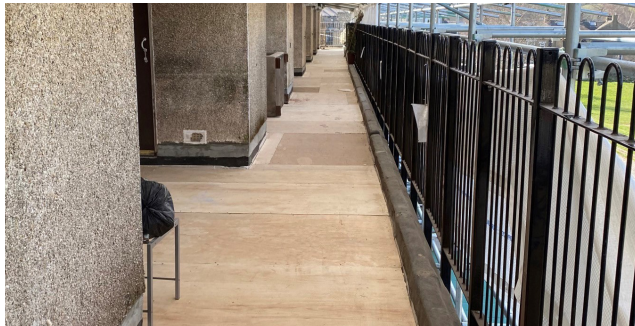
During: Tapered for Water Run Off

The slab of this structure did not provide a suitable surface meaning a layer of screed was applied to the substrate before a vapour control layer could be applied. Part of the water ingress issue was from ponding water due to the water not being able to run off to the drainage channels. To resolve this, taper insulation was mechanically fixed with two layers of 9mm plywood being laid in opposite directions, staggered to allow water to fall with the new

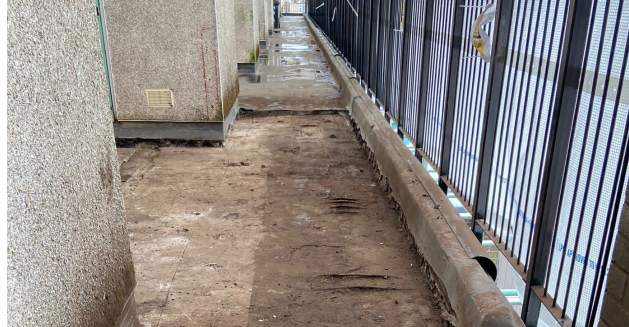
Before: Water Damaged Concrete Slab

to the concrete edge of the stair and walkways which had to be infilled and strengthened to reprofile those damaged sections.

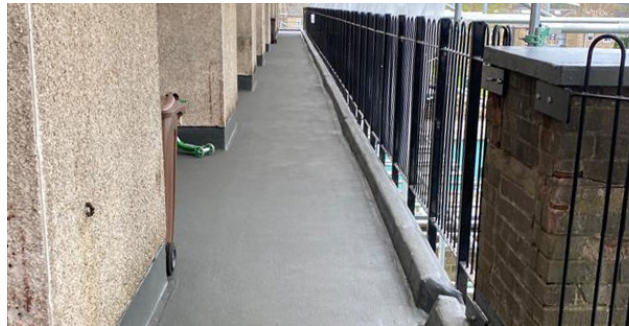
After: Watertight & Fully Protected Walkways

To finish the stairs and walkways, a fully reinforced Sika Rapid Trafficable walkway system was applied to provide a watertight and anti-slip finish for the residents of these flats.

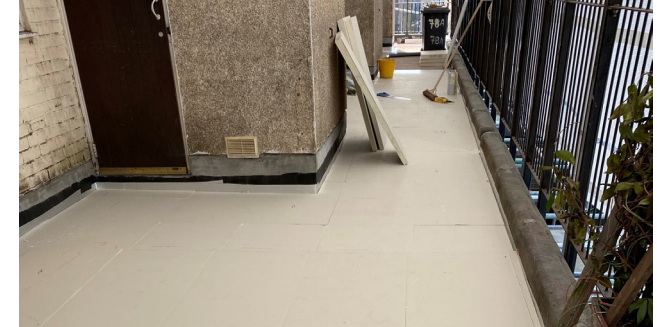
During: Tapered Insulation

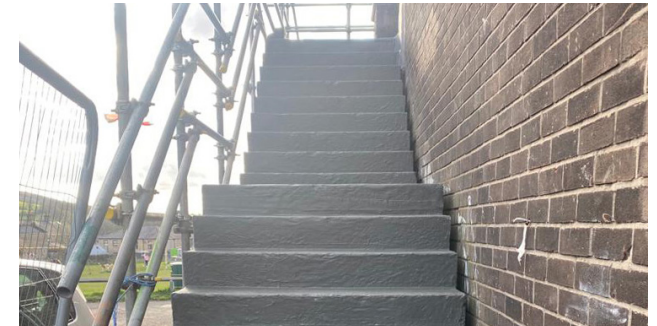
After: Aesthetically Pleasing Walkways & Stairs
