Case Study Repair & Protection

Client | Ashton Consulting Enginners | Principal Contractor

Case Study // Repair & Protection

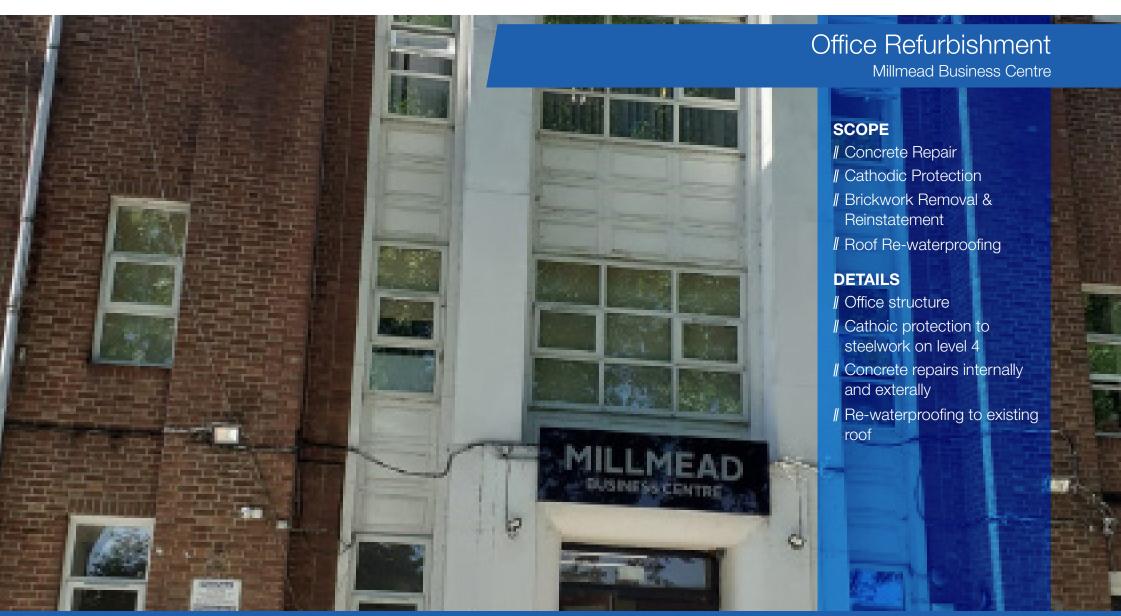
Before: Roof Substrate Allowing Water Ingress

The flat roof was allowing water ingress into the structure below. The removal of the old cast iron water tanks and other redundant elements allowed for the preparation of the roof substrate before a Vulkhem waterproofing system was applied

After: Watertight Overlay of Roof
