University Roof Re-Waterproofing

University of Westminster, London

Case Study // Roofing

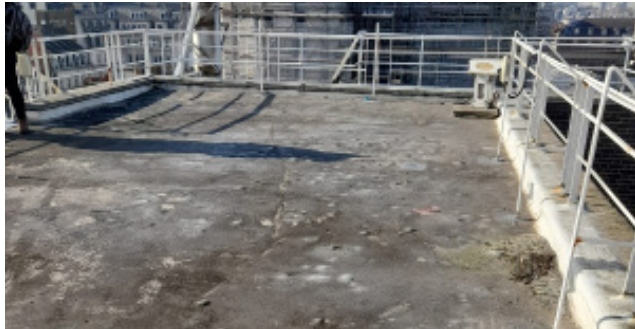
Before: Existing, Failed Waterproofing System

One two roof areas, the asphalt had failed, allowing moisture to penetrate beneath it, meaning this had to be stripped back and replaced with an alternative solution. The concrete substrate was flat rather than tapered, therefore to allow for adequate drainage, a new tapered insulation was designed and installed prior to the application of the waterproofing. An additional benefit of introducing the insulation means that these areas were thermally upgraded to meet the current building regulations.

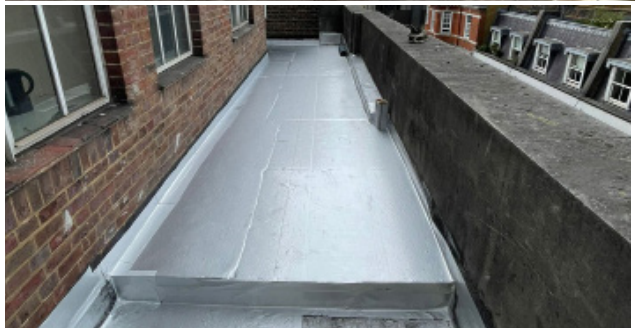
During: Installation Of Insulation & VCL

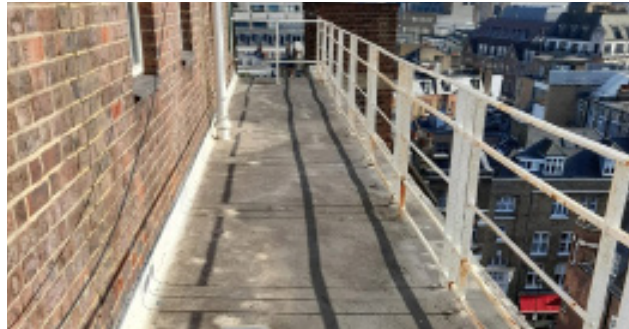
Before: Blistering To The Asphalt

Solar reflecting chippings were embedded into the existing asphalt as a protective measure against UV rays and to reduce the surface temperature in hot weather. These chippings can become loose, blocking the guttering/outlets and exposing areas of the roof which could have contributed to the cracking, blistering and overall failure of the asphalt. In order to achieve the adhesion value specified, these were removed. This presented logistical challenges over 38 individual roofs, each roof required grinding by hand while maintaining dust suppression techniques.

During Sika's core sampling, there was no moisture detected under the existing asphalt to most of the roofs. It was determined that the significant amount of blistering could be repaired using a heat lance, which reduced the amount of wastage generated, to achieve a suitable substrate on which to apply the Sika Decothane Ultra waterproof decking system. Decothane Ultra was specified

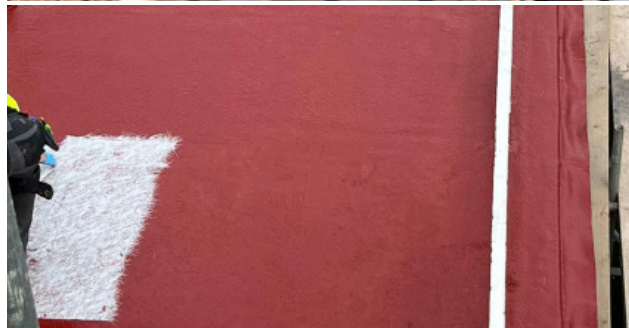
During: Application Of Reinforcement Fleece with Primer

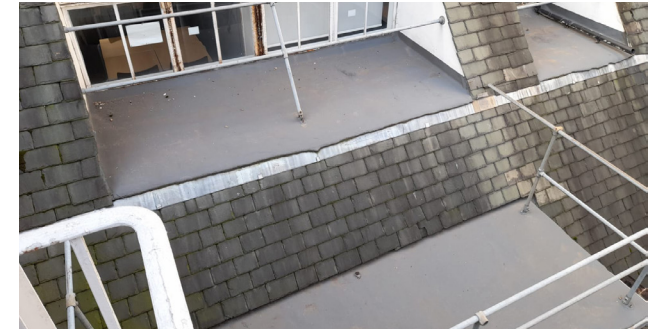
Before: Poor Asphalt Detail At Junction With Lead Flashing

- Dressing and introduction of termination bars against window reveals.
- The existing lead flashing was to remain and the waterproofing system was detailed onto those areas.
- Standard concrete and brickwork upstand details.
- Mechanical and electrical units on multiple roofs required careful attention to ensure waterproofing was achieved to both the underneath and to the upstand details.

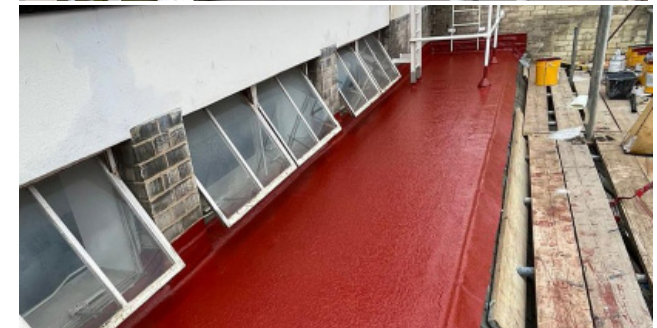
During: Low Odour, Seamless Waterproofing System

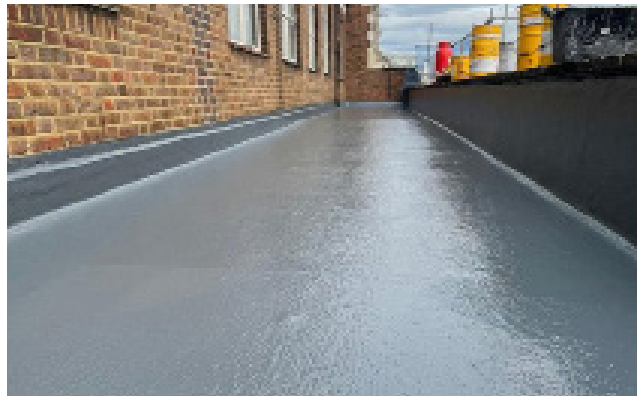
After: Thermally Upgraded & Watertight Walkway

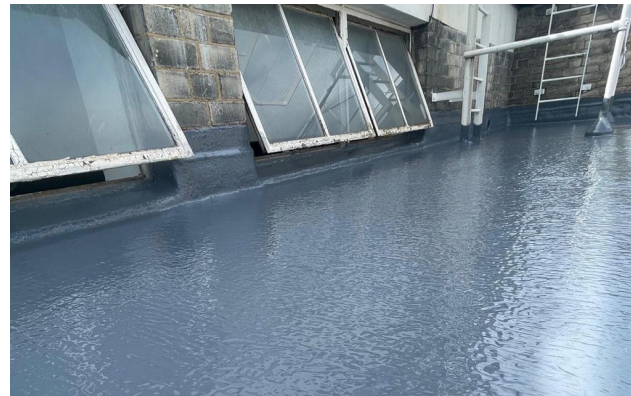
After: Fully Re-Waterproofed Roof Areas

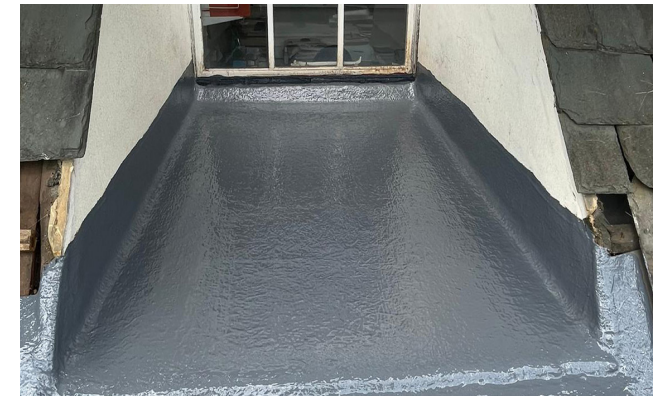
After: Waterproof Detailing Expertly Carried Out
