## £250,000 Resin Coating Works

Twickenham Rugby Football Union Stadium

# Case Study // Flooring

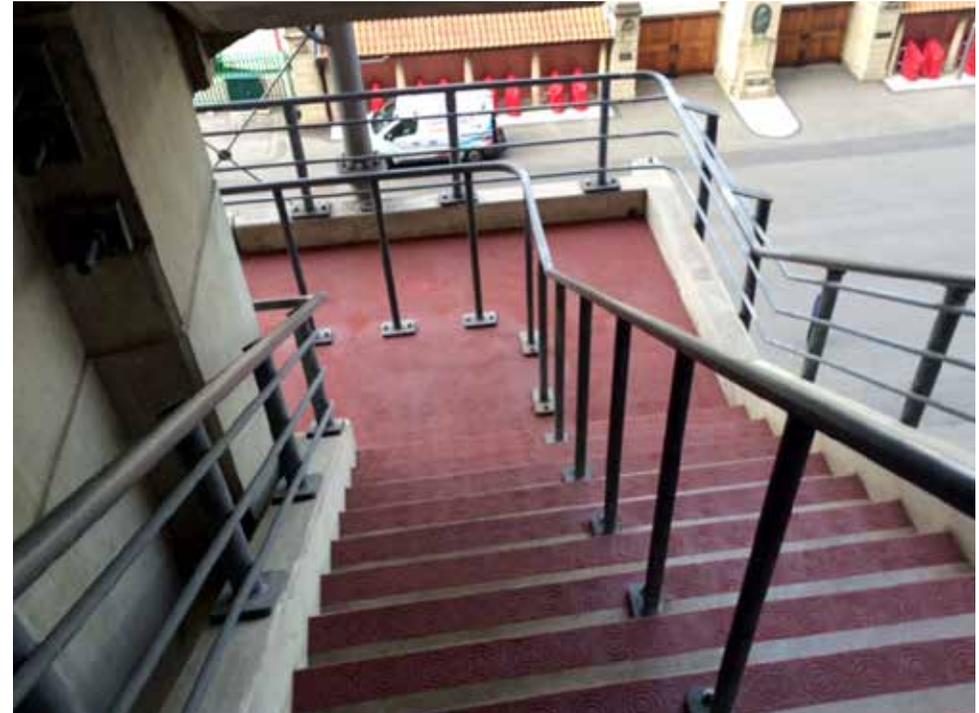
Due to the Rugby World Cup fast approaching, Cemplas had a tight programme to meet, and had 30 operatives on site at any given time during the project. Following all preparation works to the 15 external staircases and stair nosings, Cemplas operatives applied a resin system which incorporated Degafloor 112 pigmented concrete primer, this was then broadcasted with red coloured quartz to provide a degree of slip deterrent, followed by applying Degafloor 529 clear seal coat. Once the works to the external staircases had been completed, Cemplas operatives moved inside to the internal seating area of the stadium to commence with the nosing coating works to the lower, middle, and upper tiers, applying a base coat of Degafloor Resin in green, broadcasted with green coloured quartz and sealed with Degafloor 529 seal coat.
