Case Study | Repair & Protection |

Client | Bouygues | Specialist Sub-Contractor

Case Study // Repair & Protection

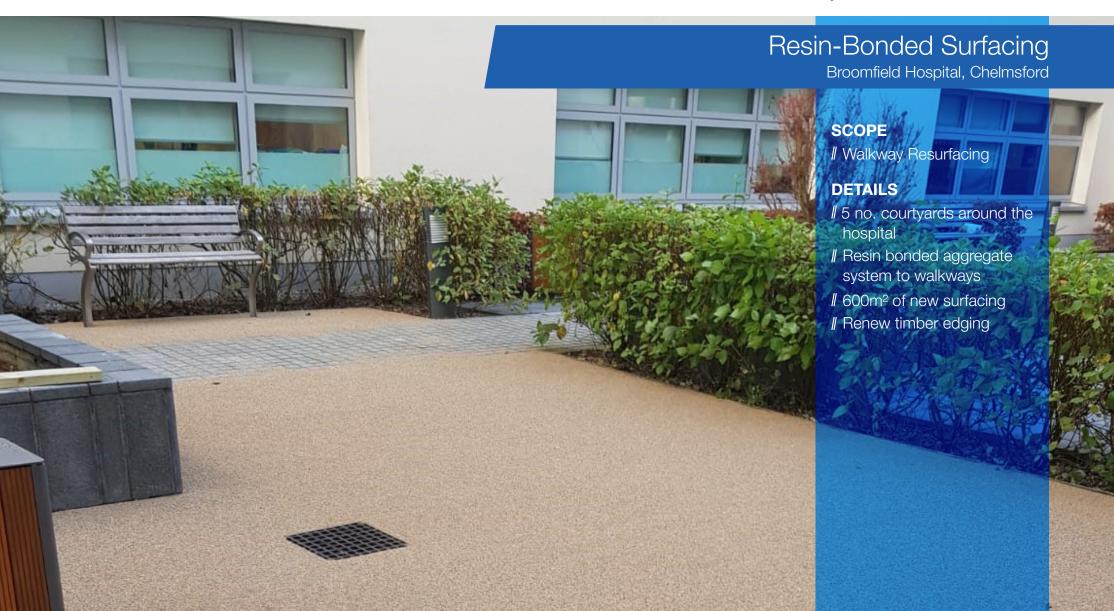
Before: Existing Surface Beyond Repair

The courtyards around the hospital were in very poor condition and beyond servicable life. Cemplas were engaged by Bouygues to replace the existing poor quality surfacing whilst at the same time improving safety (slip-resistance) and aesthetics.

a minimum - super-silent plant was utilised throughout our works. Following complete removal of the existing surface, localised repairs were required to the sub-base prior to replacement with the new resin-bonded surface.

Remmers' Resin Bonded Aggregate Pur Grip 100 system was installed to the 5 courtyards around the hospital – totaling 600m² - at a thickness of approximately 3mm.

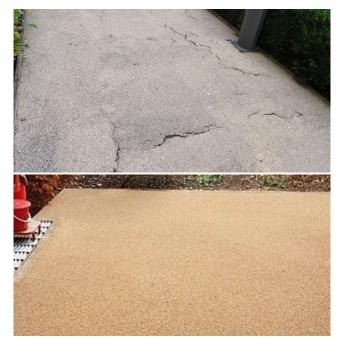
After: Repaired & Replaced

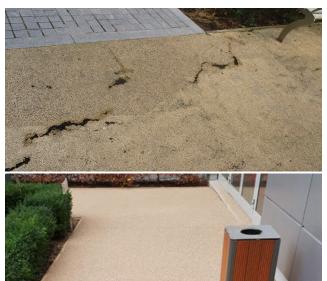
Before: Sub-Base Repairs Required

After: Timber Edging Renewed

All perimeter timber edging was also replaced within this 4-week contract with sequencing works playing an important part.
