Concourse Resin Flooring

Crystal Palace Football Club, Selhurst Park Stadium

Case Study // Stadia

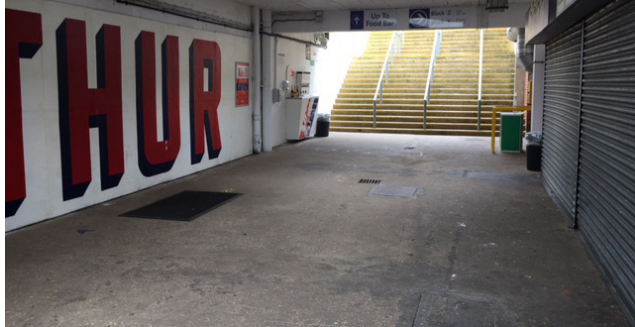
Before: Dark & Unwelcoming Environment

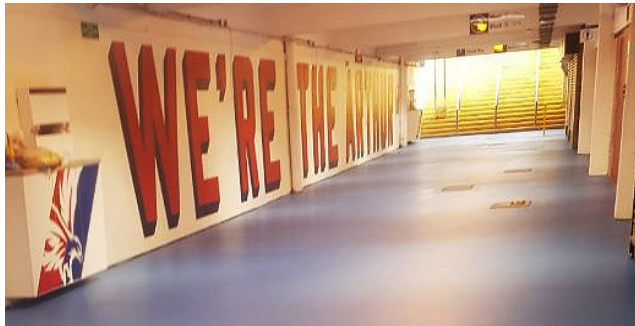
After: Repaired & Protected

The result: The concourse area was transformed from a dark and uninviting bright, safe and colourful environment.

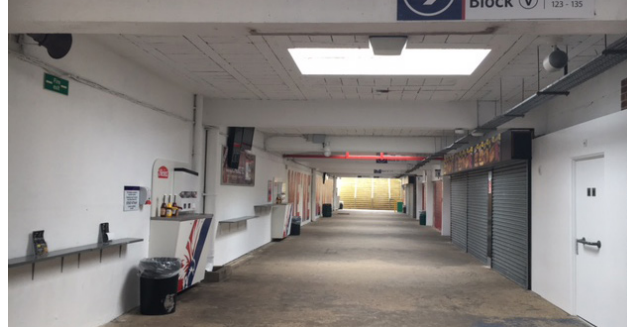
Before: Substrate Damage

The concrete substrate was mechanically prepared to including some substrate removal to an external area. Approx some 50m² of the concrete substrate had to be repaired prior to the application of the Mastertop 1324 system that the client had chosen to match with the clubs colours.

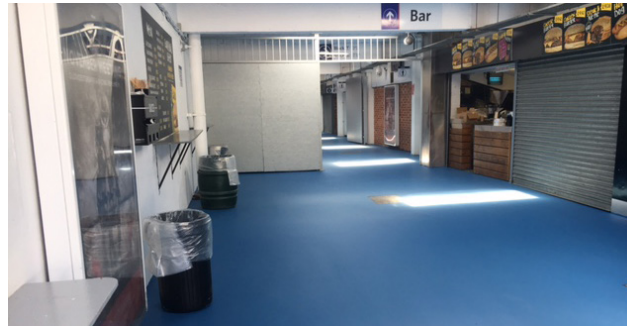
After: Enhanced Environment

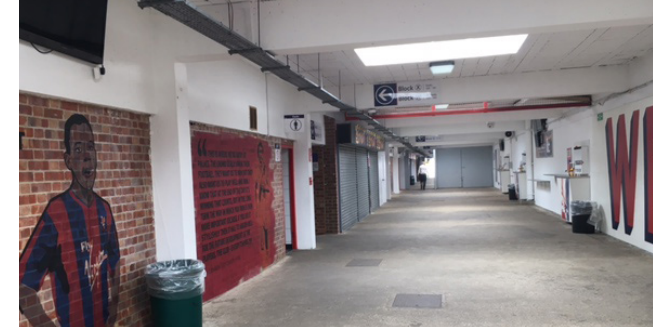
Before: Unprotected Concrete

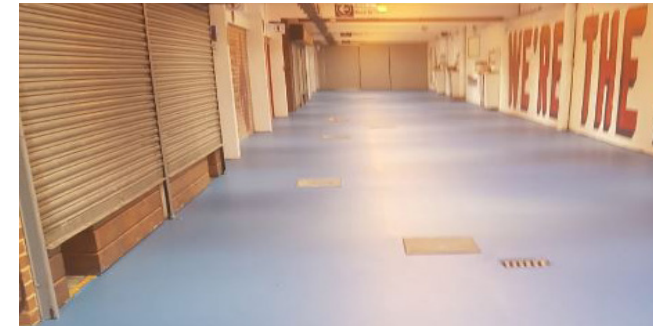
After: Light & Bright Interior Improvements
