# Walkway Waterproofing //

### Smoking Gallery Royal Albert Hall, London

- // Repair and re-waterproof existing asphalt walkway surfaces
- // Sikalastic Rapid 721 system

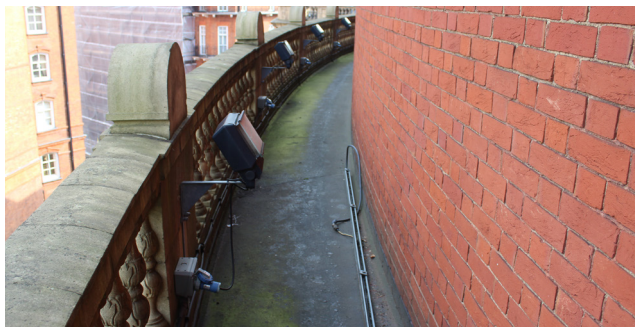
**Before:** Moss and Algae Growth

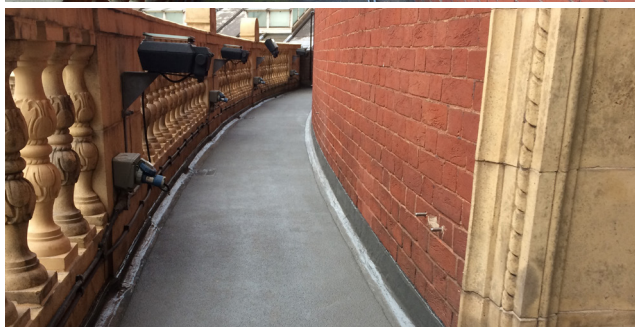
**After:** Seamless (Joint-free) Application

Our package of works had to be divided into three different phases to coincide with ongoing events within the hall and to avoid any disruption. Sikalastic Rapid 721 was applied to the walkways and upstands after the cracks in the asphalt had been repaired with Sikalastic Rapid Filler.

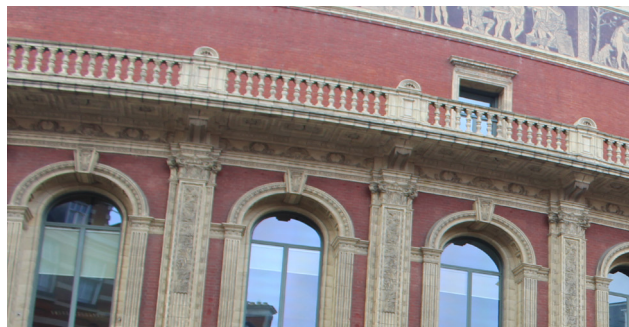
The existing asphalt substrate was damaged with numerous cracks and allowing leakage and damaging the ornate stonework soffits of the walkways.

**Before:** Smoking Gallery

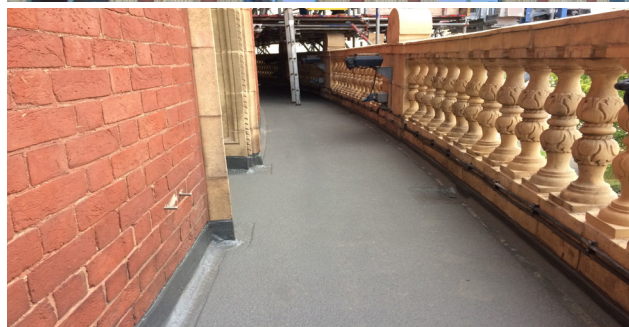
**After:** Fully Re-waterproofed Walkways

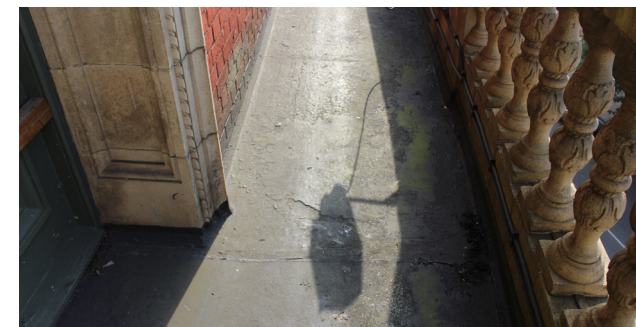
**Before:** Damaged Asphalt

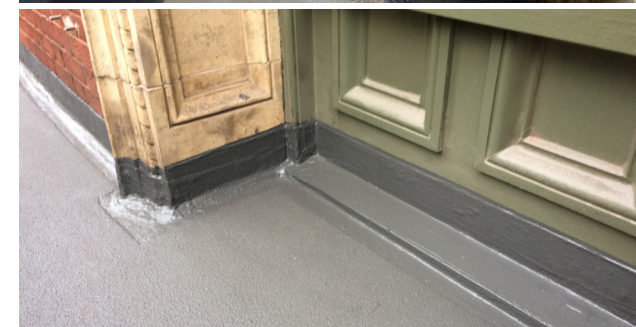
**After:** Attention to Detail
