The 17 ramps across 11 floors of this MSCP required reprofiling as the profile and geometry of the ramps caused damage to the underside of vehicles as they were 'grounding' on the existing concrete.

Cemplas Waterproofing & Concrete Repairs Ltd

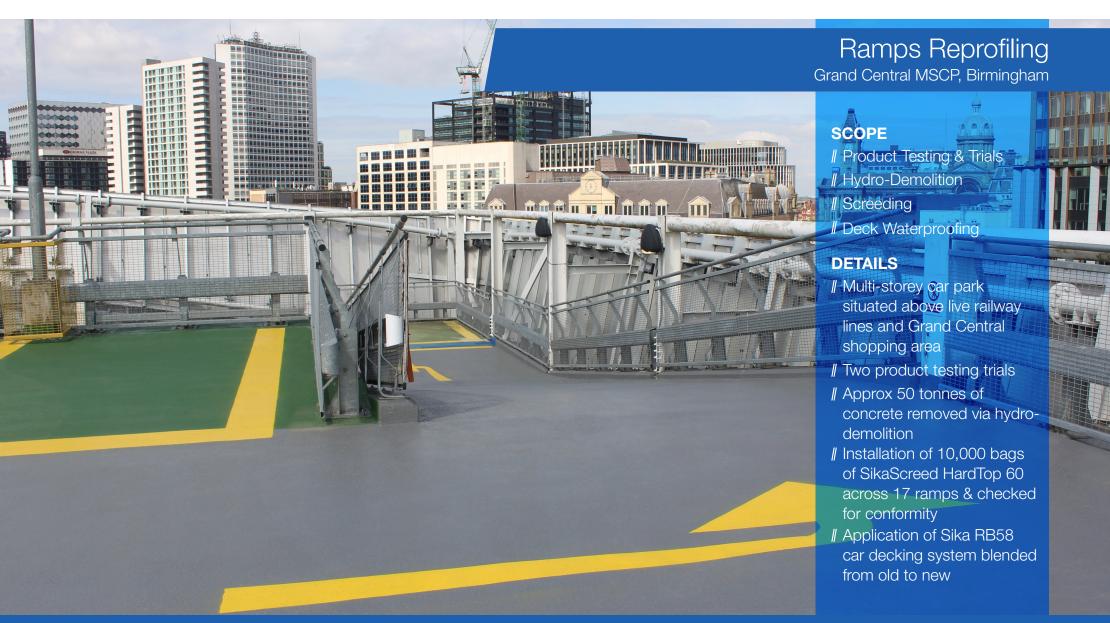
Before: Profile Causing 'Grounding Out' to Cars

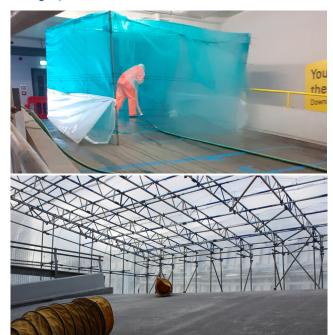
During: Hydro-demolition to Remove Concrete

During: Scaffolding & Sheeting for 'Tenting In' on Exposed Top Deck

Hydro-demolition was used to strip back the existing deck coating and remove areas of concrete substrate to the precise design set out in chainage for the precise millimetre of concrete to be removed – totalling approximately 50 tonnes being removed.

Due to the cold winter weather conditions, localised areas had to be tented in with heaters to maintain a constant specified temperature before and during the application of materials. The exposed top deck also saw scaffolding and sheeting to ensure temperatures were maintained.
