Case Study Roofing

1100

Client | Saloria Architects
Role | Specialist Sub-Contractor

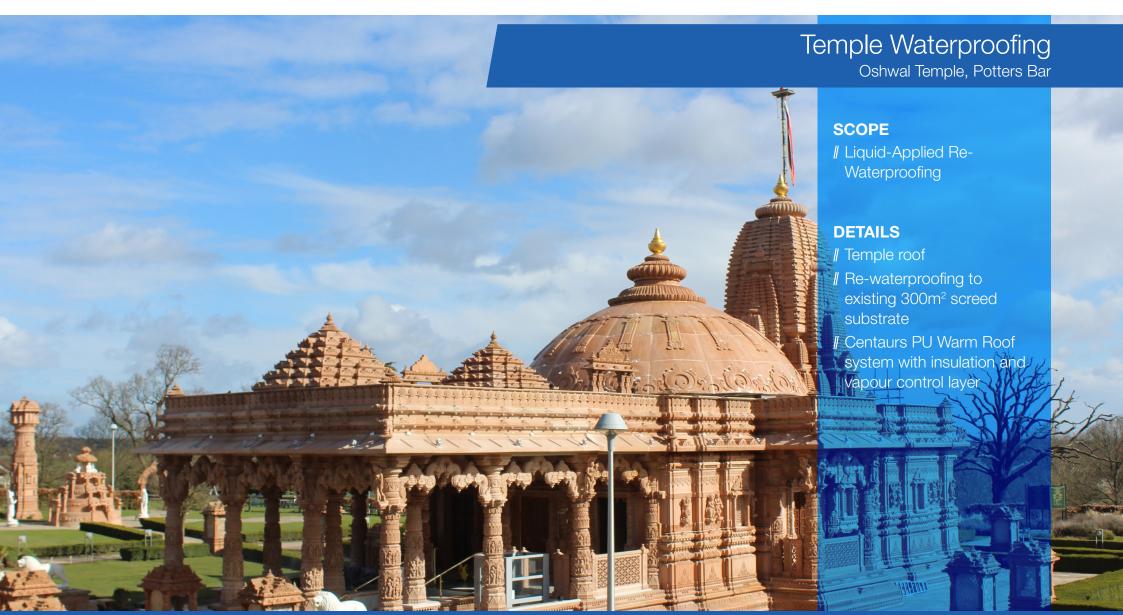
During: Removal Of Existing Waterproofing System

The temple is set within 70 acres of countryside and is a traditional load-bearing sandstone and marble structure which had been hand-carved in India by over 200 stone masters. Upon examination of the existing waterproofing system, it was noted that there was no vapour control layer allowing the insulation to become saturated due to the water ingress.

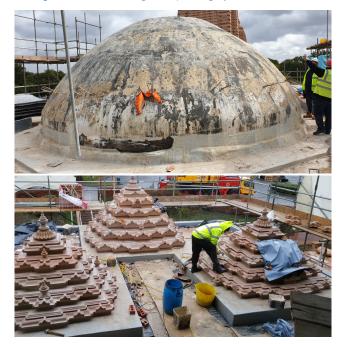
During: Reinstatement of Stone Structures

Before the roof could be stripped back to the screed substrate, the stone structures and dome tiles had to be carefully removed in sections and securely stored to protect them from any unwanted damage while works were taking place.
