Case Study Podium Waterproofing

Case Study // Podium Waterproofing

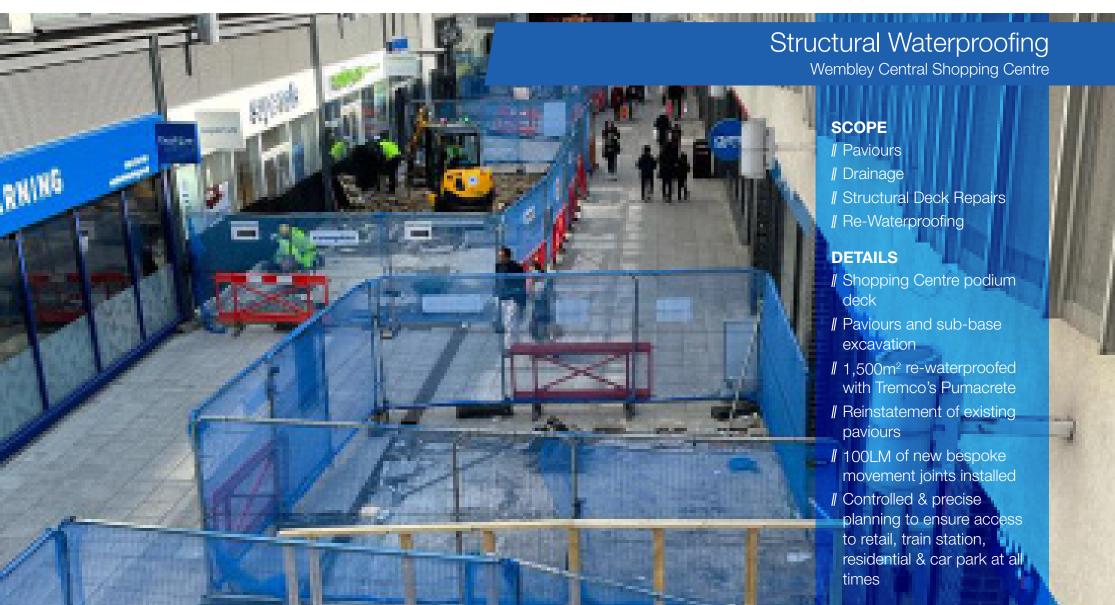
Before: Podium Deck With Water Ingress Into Train Platform Below

Before: Movement Joints Leaking Into Car Park Below

Tremco's CPG Pumacrete podium deck membrane. bespoke movement joints and a new drainage matting layer. As well as overhauling all of the cast iron drainage system and installation of new drainage channels for surface water run-off.

A new substrate using varying materials including insulation and screed back fill to ensure weight loads were maintained and were installed to bring the build up back to existing levels followed by reinstatement of paviours.

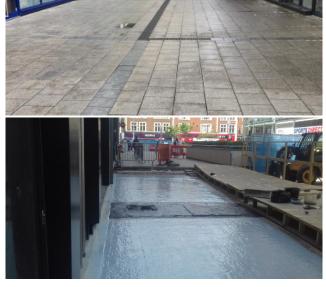
During: Podium Deck Waterproofing Membrane

The existing paviours and sub-base were excavated to expose the reinforced concrete podium deck slab and undertook detailed drainage surveys. The extensive waterproofing works involved the installation of 1,500m²
