## Shopping Centre MSCP's Refurbishment

The Plaza Shopping Centre, Wokingham

# Case Study // Car Parks

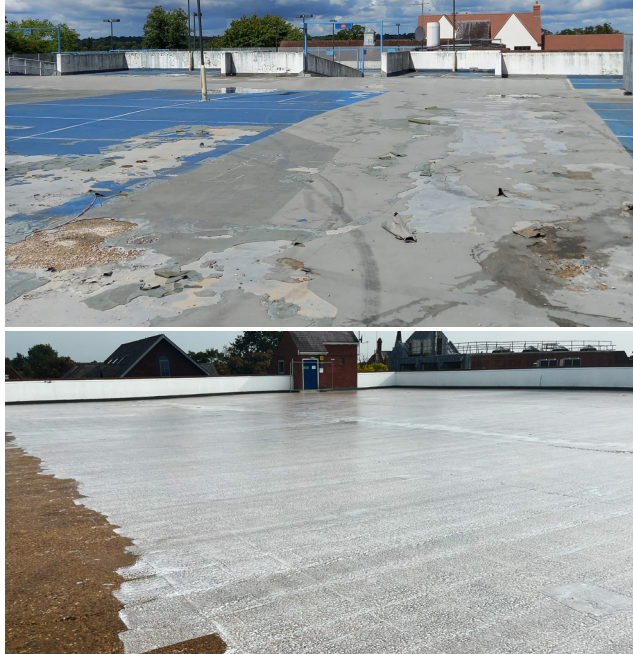
**Before:** Delaminated Deck Coatings

**During:** Pre-Primer To Combat Outgassing

in a very poor condition. Delamination was occurring across the whole car park, primarily focused to the drive aisles. This system was removed using a specialist 'ride on' planer with works commencing on the top deck then progressing down through the car park, level by level.

substantial outgassing of the concrete, likely caused by the ingress of moisture into the concrete through the existing failed coating.

Westwood's 821 pre-primer was applied, sealing the concrete slab and stopping the outgassing phenomenon at the source of the problem, thus eliminating the risk of pin holes through the decking system. Westwood's Wecryl fully crack bridging waterproofing system was then applied to the 3,330m<sup>2</sup> top deck.

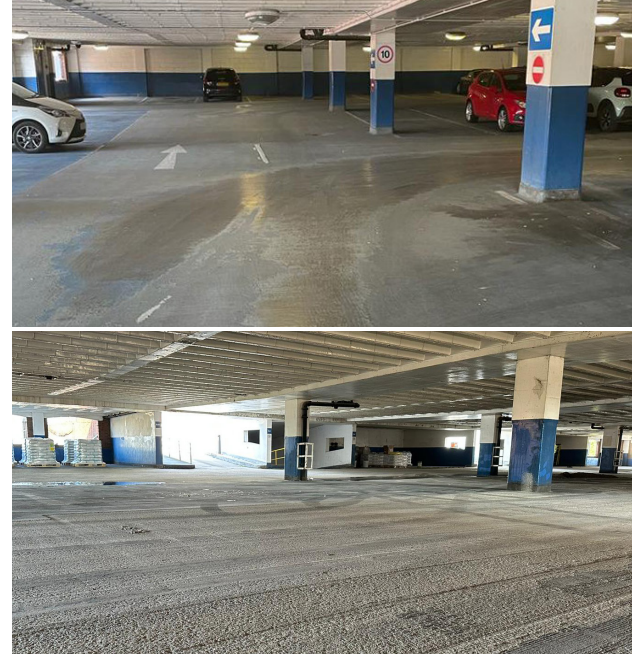
**Before:** Dark & Unwelcoming Environment

**During:** Concrete Repairs Completed and Decks Prepared

Significant repairs were required to the concrete substrate on the top deck. There were also concrete defects to the internal decks, soffits, columns and walls throughout the structure, leading to in excess of 25 tonnes of defective concrete being broken out. Before concrete repairs could be completed, sacrificial anodes were installed to the reinforcement to alleviate the ongoing corrosion.

The waterproofing of the top deck allowed for the levels below to be enhanced. Concrete repairs and resin injection crack repairs were completed to the concrete surfaces throughout the car park, previously unachievable due to water ingress. Followed by anti-carbonation coatings, protecting the structure from the underside whilst the

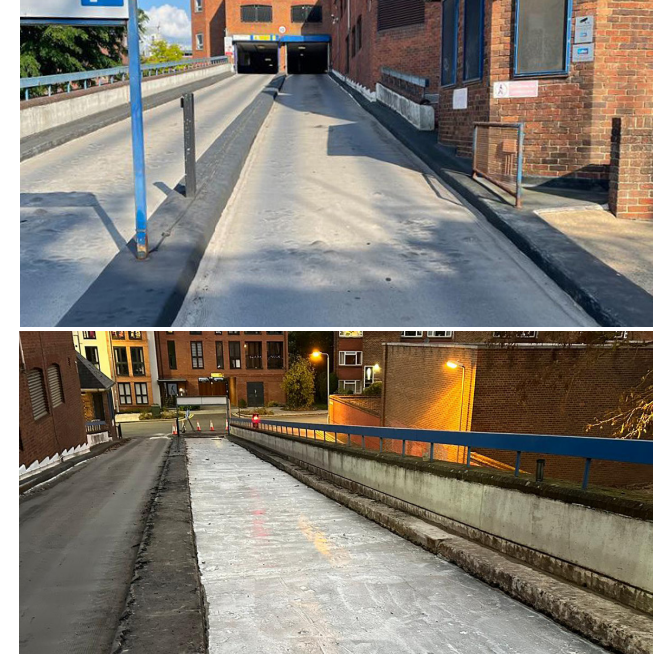
**Before:** Failing & Blistering Asphalt To The Ingress/Egress Ramp

**During:** Traffic Management to the Ingress/Egress Ramp

bottom of the ramp, a buried waterproofing system was installed then finished with a tarmac wearing layer. Cemplas kept the car park operational throughout these works by introducing a Highways approved traffic management system from the main road into the multi-storey car park, creating a safe and efficient one way system so vehicles could enter on one side of the ramp.

The other side of this ramp was stripped of the failing and blistering asphalt, back to the concrete substrate which was repaired and levelled using a rapid setting repair system to speed up the process. It was critical that these areas were completed promptly and returned to use within the two week period granted by Highways.

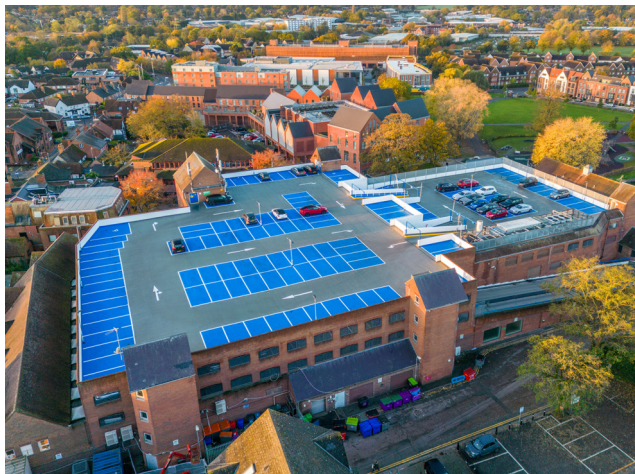
**After:** Aesthetically Enhanced Top Deck

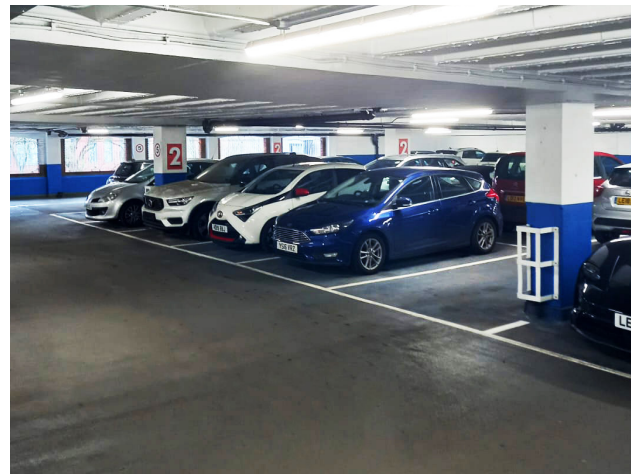
**After:** Light & Bright Interior Improvements

These new protective, yet decorative coatings, combined with a new lighting system on the roof and interdecks now offers patrons a bright and safe environment in which to park.

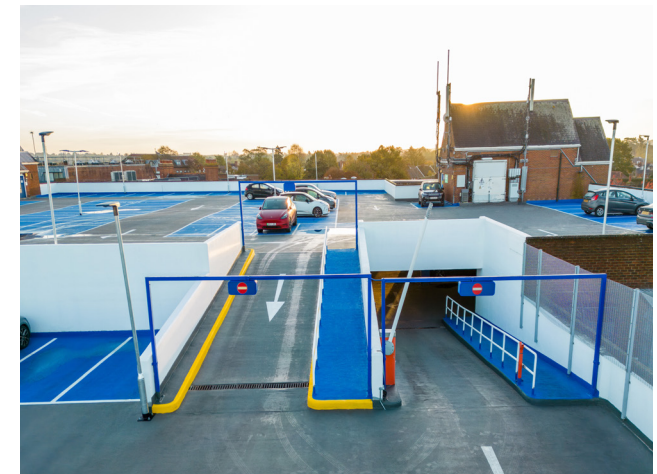
**After:** Fully Protected Decks & Ramps
