## Secondary Means of Escape Walkways

Whitechapel Train Station, London

# Case Study // Roofing

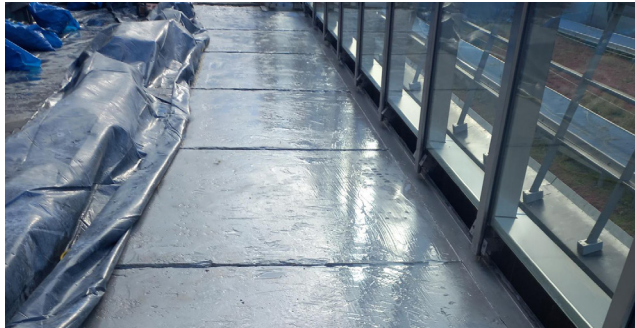
**Before:** Unsuitable Expansion Joint Size

Additionally, the 46 joints between the pre-cast concrete planks, spanning a total length of 161Lm, needed to be widened from 10mm to 30mm to allow for the necessary structural movement. In order to fortify the structural integrity and ensure robust reinforcement, a vital step involved the application of cementitious coatings onto

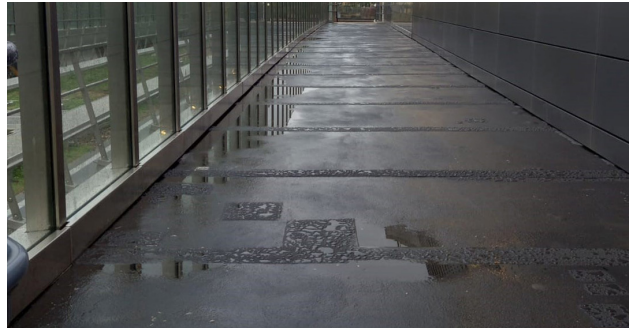
**Before:** Patch Repairs Previously Undertaken

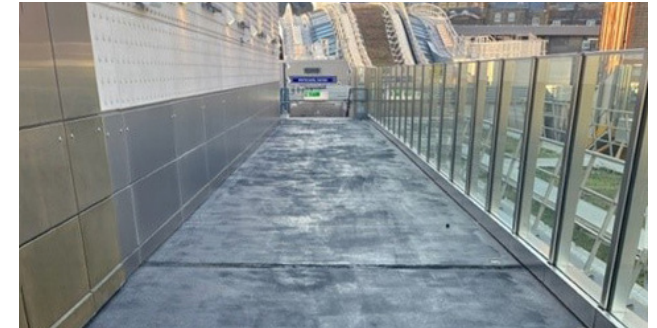
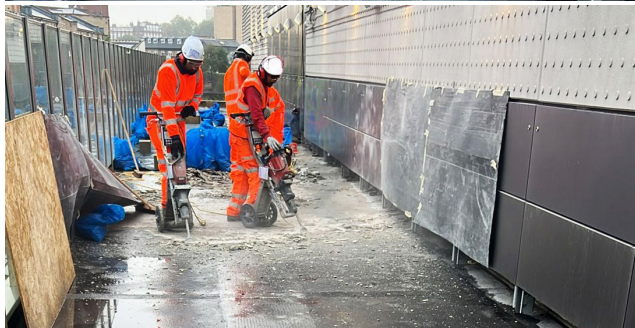
**Before:** Walkways In Poor Condition

**Whitechapel Train Station, a crucial transportation hub, encountered a critical problem with defects to the fire escape walkways to the east and west sides. Despite two waterproofing attempts, both of which had failed, water started seeping into the concourse and control rooms below, posing serious safety concerns for passengers and staff. In order to ensure the station's safety and maintain uninterrupted functionality, it was imperative to take swift and decisive measures to address and rectify the underlying issue, thus ensuring the safety of personnel and the seamless continuation of operations.**

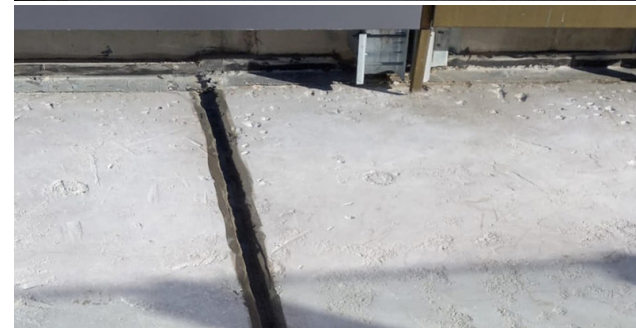
**During:** Removal Of The Existing Waterproofing System

The deficiencies uncovered within the current system necessitated the meticulous removal of the waterproofing membrane down to the foundational substrate using precise planing techniques. This thorough process was deemed essential to address the underlying issues effectively and lay the groundwork for subsequent corrective actions, ensuring the integrity and long-term durability of the structure.

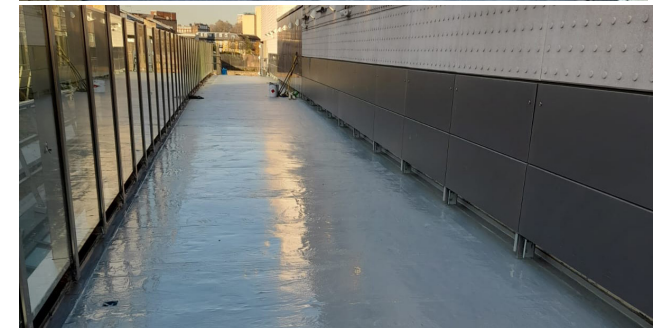
**During:** Widening Of The Expansion Joints From 10mm to 30mm

the recently widened joints. This process was crucial in providing a resilient protective layer, enhancing durability, and thereby bolstering the overall strength of the structure.

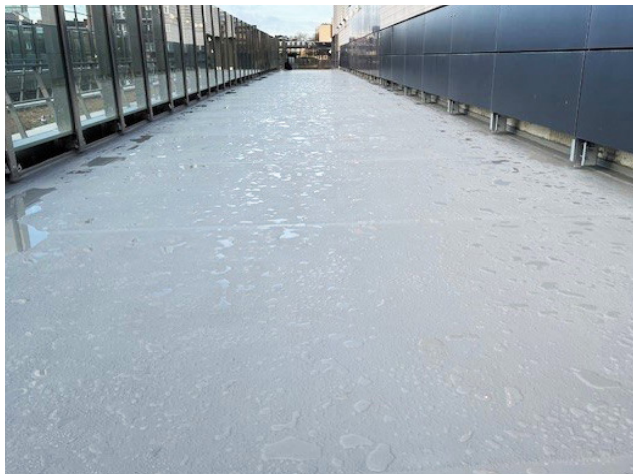
**During:** Application Of New Waterproofing System

A new fabricated metal upstand detail was installed to add extra reinforcement and protection to vulnerable areas. Prior to applying a specialised waterproofing system by Kemper, known as their AC Speed system, all surfaces, including the upstands, were prepared using hand-held tools.

It consisted of two layers of reinforced fleece seamlessly joined together rather than overlapping to provide complete protection and reinforcement while maintaining an aesthetically pleasing appearance. In order to improve safety of passengers and staff on these evacuation routes, the surface was finished with an anti-slip wearing course. This course passed specified slip tests using the Pendulum Test Value, achieving values of 45 in wet conditions and 65 in dry conditions.

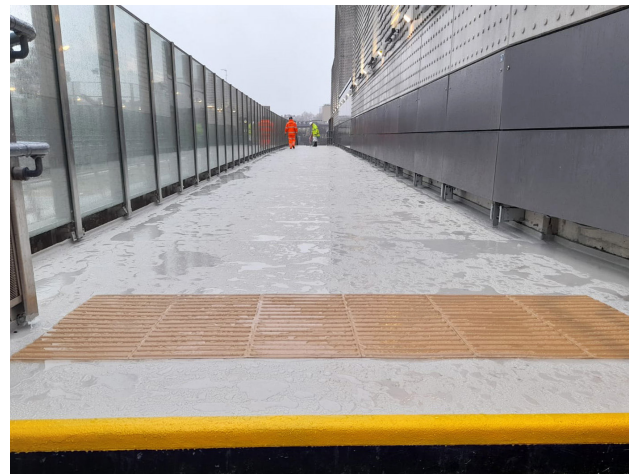
**During:** Watertight Walkways

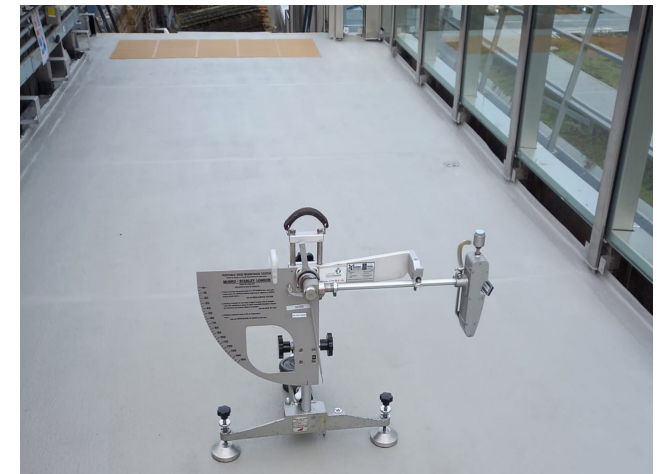
**After:** Walkways Enhanced & Upgraded

Corduroy tiles, along with painted yellow nose treads on the steps, were installed at both ends of the two walkways. This addition was aimed at enhancing the traction and clearly
