Telephone Exchange Building Refurbishment

BT ATE Accrington

Case Study //

Concrete Repair //

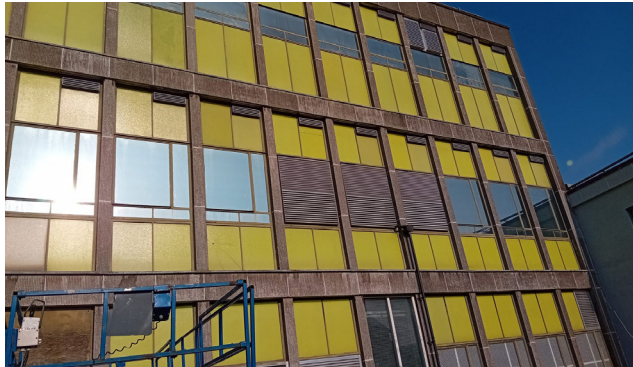
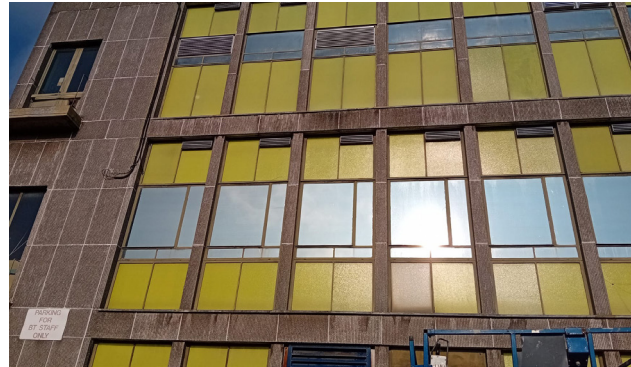
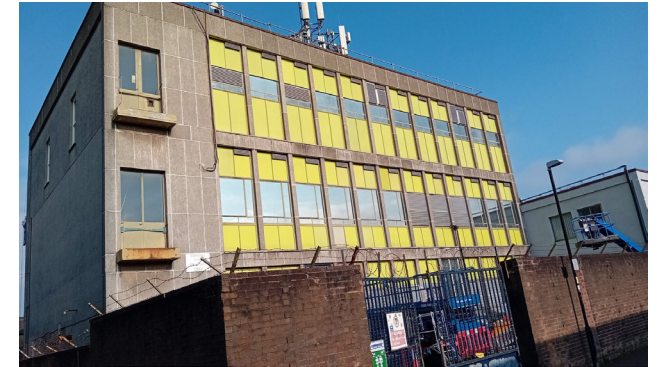
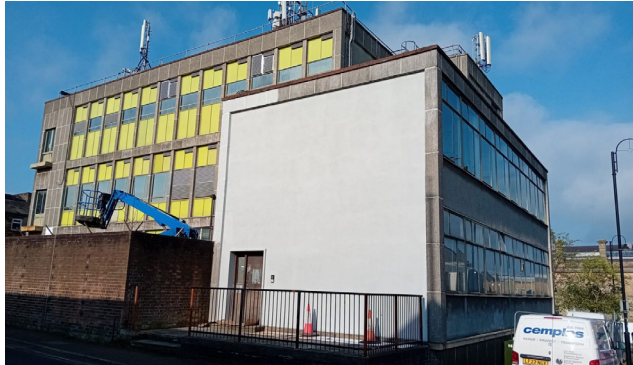
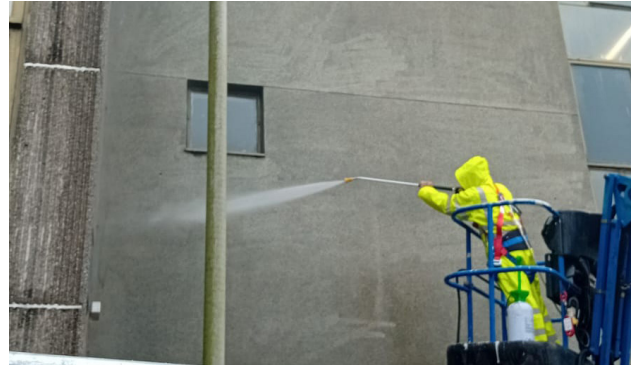
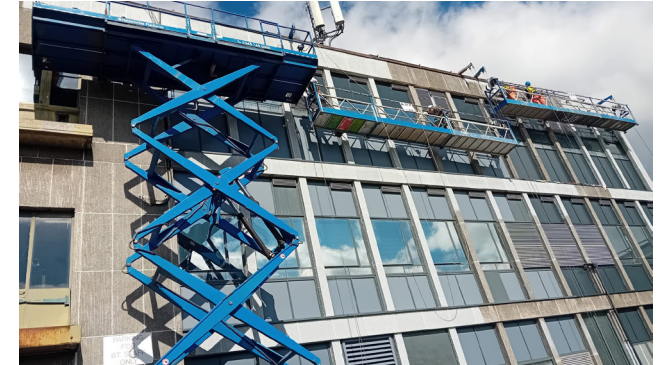
Over time, the structure's concrete elements – columns, beams, fasciae and pre-cast aggregate – had deteriorated significantly, with widespread spalling caused by prolonged exposure to moisture and environmental pollutants. A further problem was the aged and weather-beaten façade, which necessitated a comprehensive intervention to both restore functionality and enhance the aesthetic appeal.

adhesion, mechanical strength and resistance to carbonation, all of which are critical factors in ensuring the longevity of reinforced concrete structures. To achieve a consistent substrate finish an additional surface protection fairing coat was applied, enhancing durability and aesthetic uniformity.

Due to the long-term challenges associated with exposed concrete, a targeted corrosion prevention strategy was implemented. To actively prevent further deterioration of the steel reinforcement a corrosion inhibitor was selected. Sika Ferrogard 903+ was chosen for its effectiveness and applied to 450m², helping to extend the structures lifespan. To

further enhance resilience, an anti-carbonation coating was applied over the same area across all four elevations, forming a protective barrier against CO₂ ingress and moisture, both of which contributed to reinforcement corrosion over time.

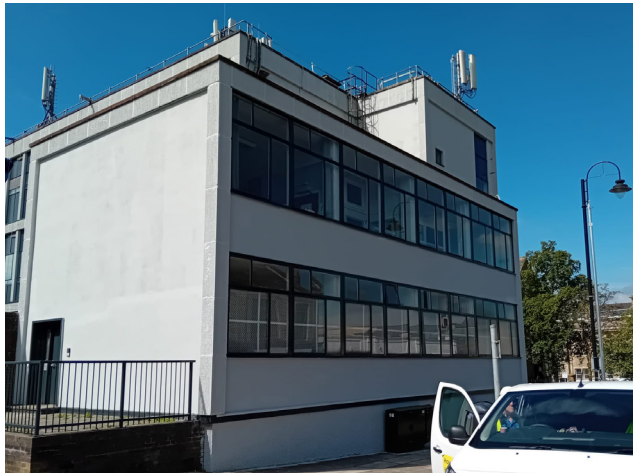
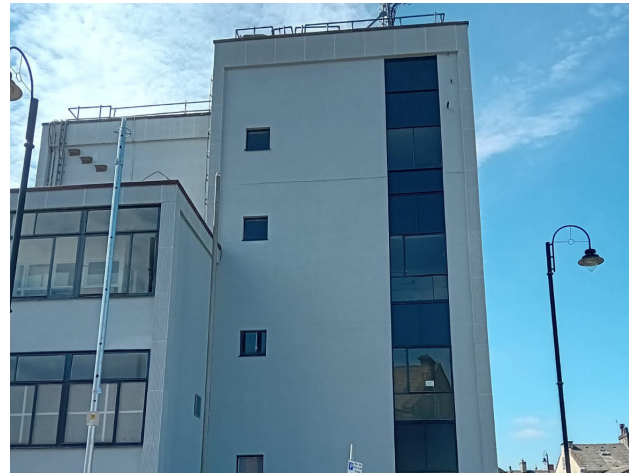
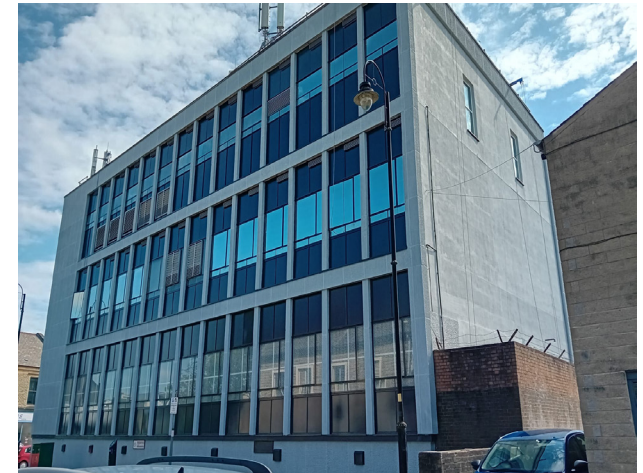
This strategic combination of materials and protective treatments ensured the structures long-term durability. With the structural rehabilitation complete, attention turned to the visual enhancement. All four elevations of the building underwent extensive redecoration, with metal-framed windows, spandrel panels, doors and frames meticulously repainted. Thoughtful colour selections ensured that
