External Staircase Refurbishment

Serious Fraud Squad HQ

Case Study // Concrete Repair & Protection

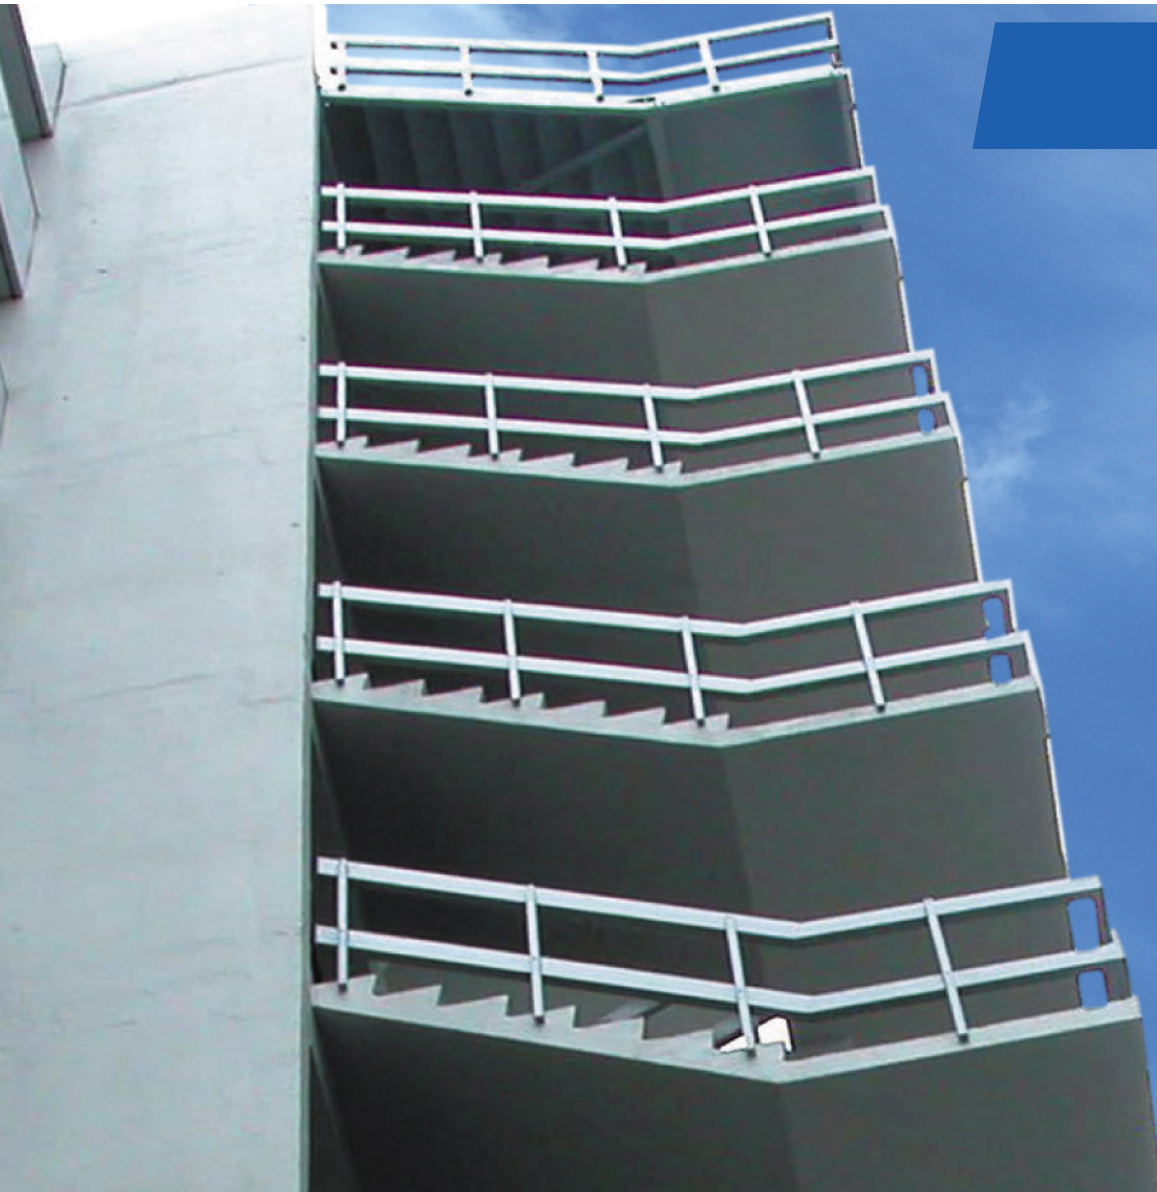
Due to Health and safety issues, major concrete repairs were required to the dilapidated in-situ concrete external staircase of this 1960s building which were found to have large areas of spalling concrete falling away, and steel landings which were heavily corroded and deemed unsafe.

Repair areas were identified and then treated including undertaking hand placed repairs; an overall levelling coat was applied followed by two coats of anti-

carbonation protective treatment. All works were undertaken using the Sika Monotop Repair System.

The areas of the staircase which were manufactured in steel, and identified by the Engineer as being corroded beyond repair, required Cemplas replacing a number of the steps, and welding into position new landings. All other areas of steel were shot blasted, then primed and coated using zinc rich protective coatings including the handrails from top to bottom, and any missing or damaged bolts were replaced.
