Client | LSG Sky Chefs
Role | Principal Contractor

The scope of this refurbishment was to carry out substrate repairs and re-waterproofing to the existing concrete barrel roof measuring some 1,600m².

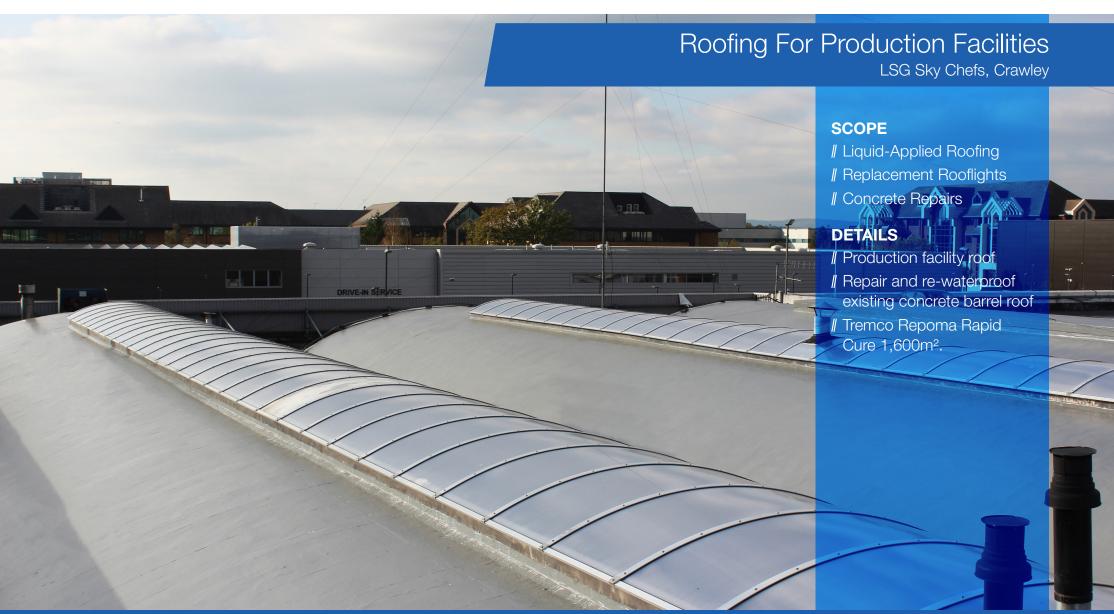
Before: Aged-Damaged Structure

The existing mineral felt membrane was badly ageddamaged in areas with extensive defects used by vegetation growth. Following removal of the mineral felt the

exposed 20mm cementitious screed was very friable and had to be stabilized prior to being overlayed
