Case Study Repair and Protection

Client | Kier Construction
Role | Specialist Sub-Contractor

## Case Study Concrete Repair and Protection

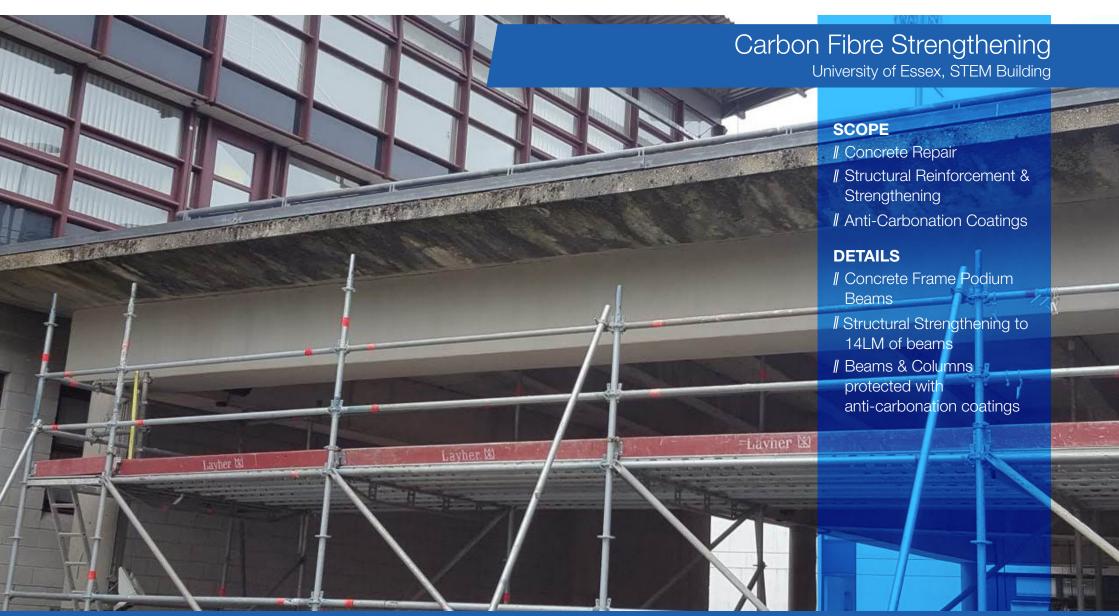
**Before:** Structurally Unsound Beams

Upon completing a non-intrusive cover meter survey and a carbonation test; it was discovered that the second beam – which would endure heavy use – required

strengthening to support the loads. The results showed noteworthy corrosion to the existing footbridge while the columns demonstrated steel corrosion and delamination of the concrete. To reinforce the steel a corrosion-inhibiting protective mortar was utilized before the concrete could be repaired.

This was followed the installation of Mapeband – a high-

strength carbon fibre fabric – to the 14LM of beams and columns to strengthen and reinforce them. A 2mm coat of Mapelastic Guard was applied to all surfaces to provide effective anti-carbonation and anti-corrosive protection to the structural elements.
