Case Study

Hughenden Road Balconies

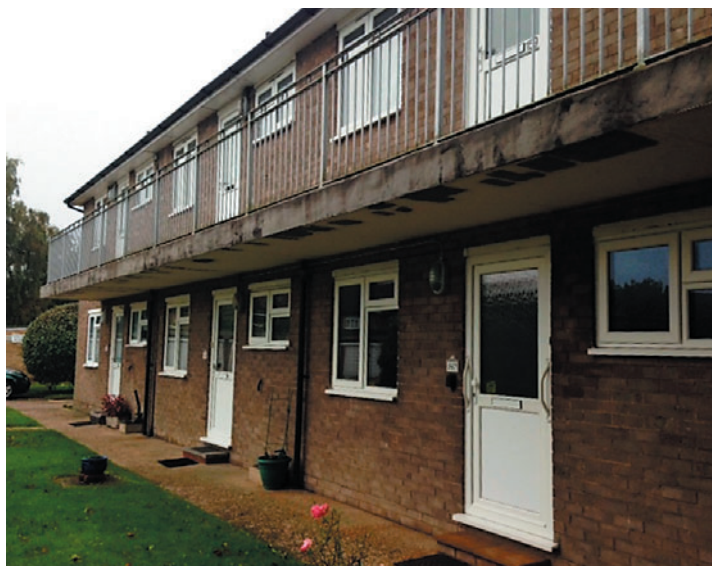
Cemplas operatives hammer tested all areas of concrete to determine the extent of each repair, square cut around the area to avoid feather edging and then broke out defective concrete back to sound substrates and exposing any steel reinforcement. Once preparation had been completed all reinforcing steel together with the substrate was primed using Sika Monotop 610 and the areas where the defective concrete had been removed were reinstated using Sika Monotop 615.
