Case Study

1 Grand Avenue, Hove

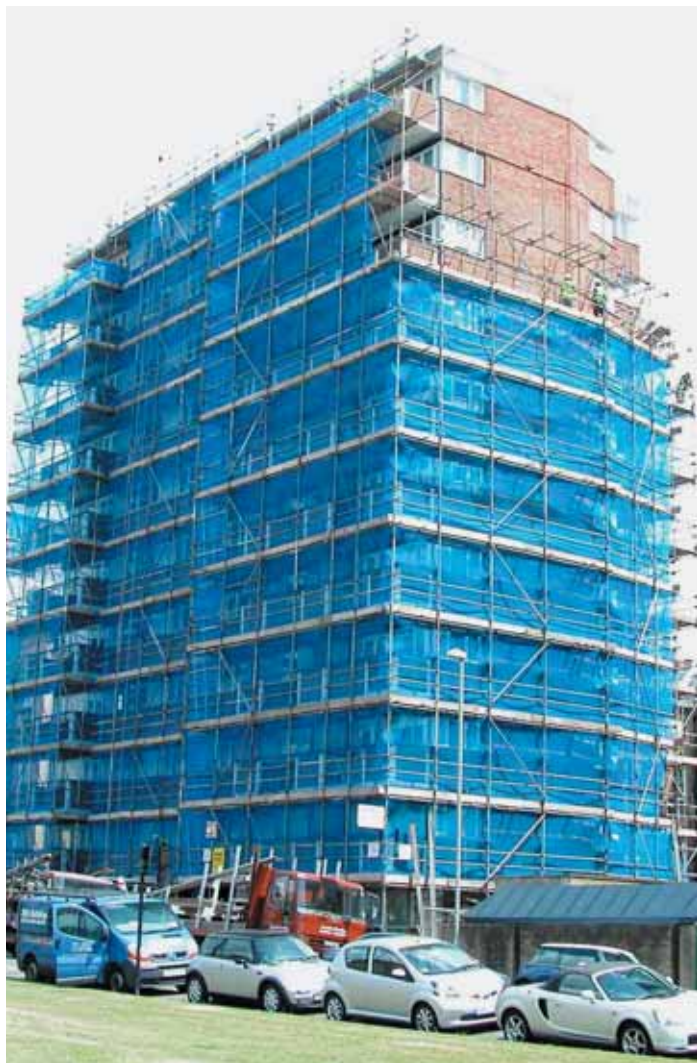
1 Grand Avenue Hove is a late 1960/70s Multi Storey private residential block situated in a prime seafront location.

Due to the coastal location, a high degree of problems with the structure were evident, including evidence of spalling to the private balconies and ring beams, but most critically, the ring beams that were supporting the outer brick skins of the external flank walls were completely delaminated.

Cemplas began the extensive remedial work by removing all the brickwork to the buildings outer skins and cutting off the ring beams flush.

The ring beams were then replaced by Cemplas with steel Ancon shelf support anchors that were resin fixed to the remaining face of the concrete, and accurately positioned to support the new outer skin of brickwork.

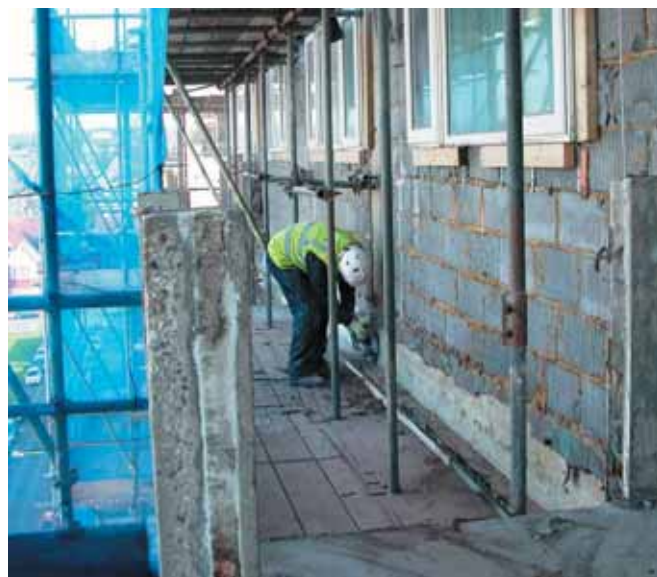
The concrete balconies were treated by means of shot blasting to remove the previous coatings. Ronacrete Ltd's full Ronabond protective system was utilised. Repairs to the Concrete were reinstated with Ronabond HB40 Repair Mortar.

Joltec Anti-carbonation Coating was applied to Vertical Surfaces, and Zolpacryl Anti-carbonation Coating was applied to the Balcony Soffits .

Ronabond Cover Plus 150 was also used to provide additional protective 'cover' to the steel reinforcement.
