Case Study

Control House, South Pier, Great Yarmouth

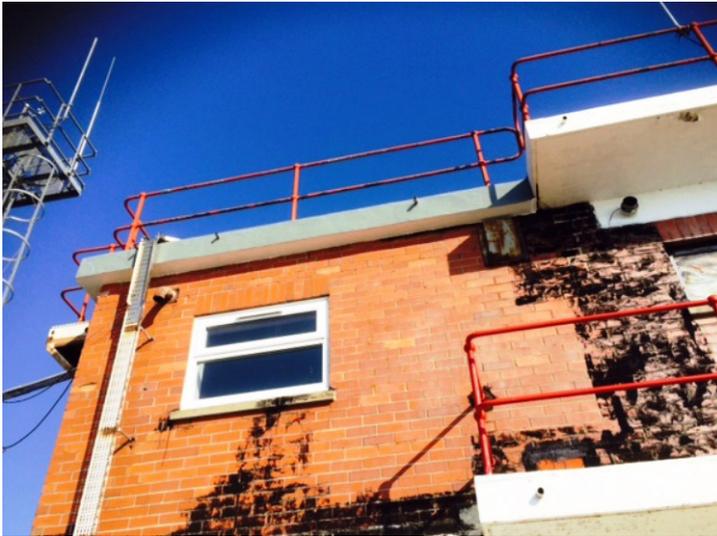
Cemplas Waterproofing and Concrete Repairs Ltd were invited by the Great Yarmouth Port Company Ltd (GYPC) to undertake a survey and inspection of the Control House to the South Pier in Great Yarmouth which had been closed off to members of the public due to the unsafe nature of the concrete elements of the structure.

A cherry picker and welfare unit were installed on site, and Cemplas operatives began by breaking out all areas of defective concrete back to a sound substrate, and exposing the steel reinforcement bars. Due to the extent of some of the corroded steel, they had to be replaced with new reinforcement bars.

All steel reinforcement was then thoroughly cleaned and primed with Weber Keycoat rust inhibitor.

And sacrificial anodes were installed to the steel rebars prior to reinstating the defective concrete using Weber HB40 repair mortar.

Once the entire concrete repair works had been completed, Cemplas applied Weber Cote primer and two coats of Weber Cote EC to the areas of repaired concrete.

To complete the project, a Waterproof Resin Coating was applied to the top concrete beam where there was an existing asphalt overhang.
