Case Study

Crossness Sewerage Treatment Works

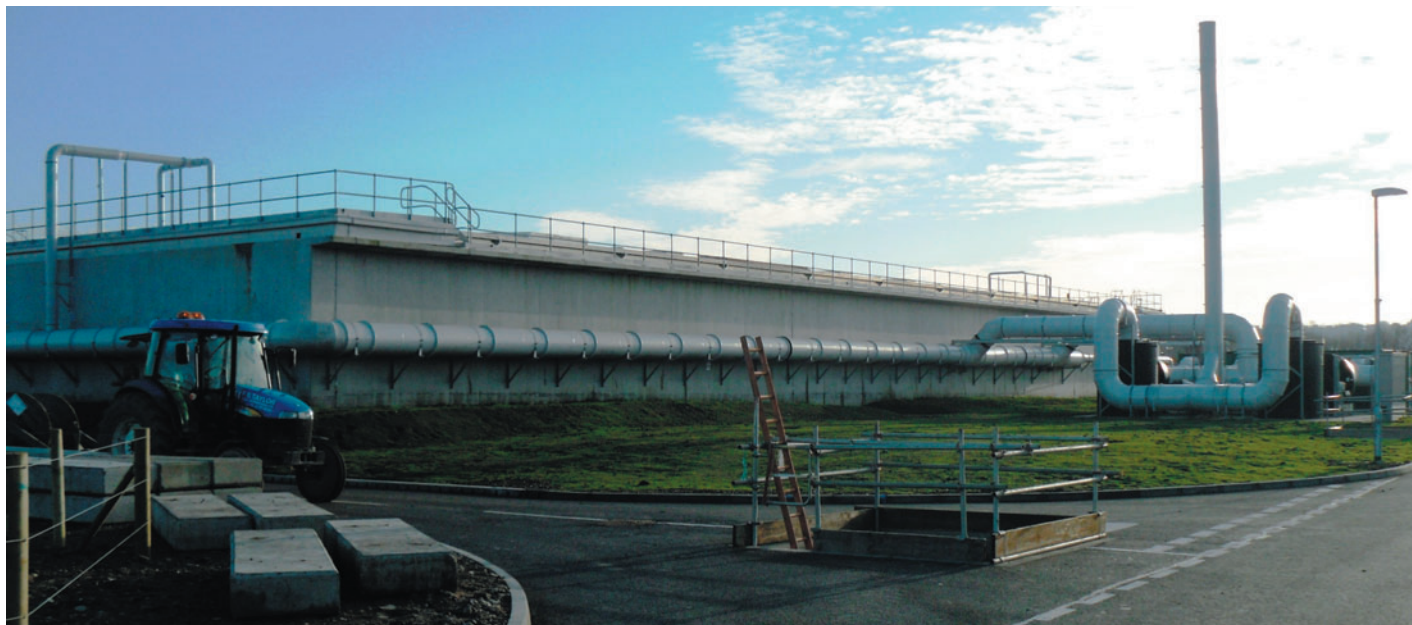
Cemplas surveyors undertook a lengthy survey reporting the tanks had cracking and leakage which was combined with defective movement joints and rust spots. Cemplas also undertook a survey to the plant room floor which was in a poor state.

To seal the leaking cracks to the tank walls Cemplas injected Sealboss polyurethane resin. Defective movement joints were repaired using a high build polymer modified repair mortar and the mastic movement joints were reinstated using Fosroc Nitoseal. Operatives then cut out the rust spots and repaired these areas with specialist repair mortars.
