Car Park Waterproofing

Multistorey Car Park, Hyde Park, Hayes

Case Study //

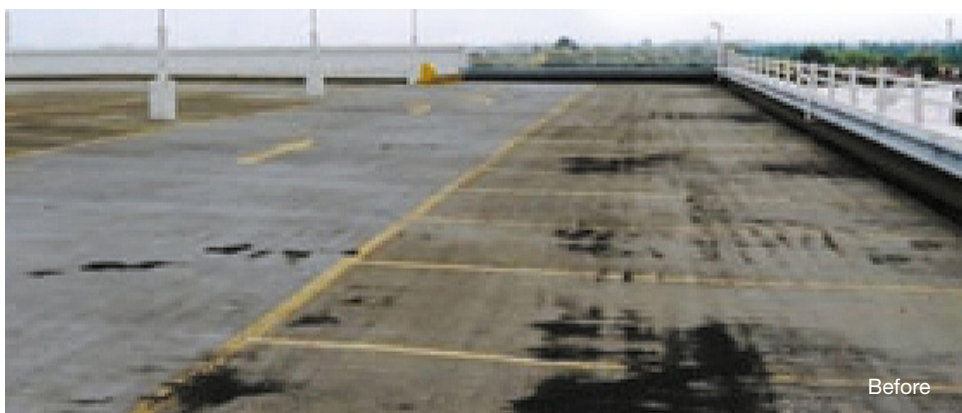
Before

Following a detailed survey of the top deck fully skilled trained and qualified Cemplas operatives identified cracks in the existing coating and with failed joints which were causing water to leak through to the deck below.

The remedial works comprised of Cemplas preparing the existing car park top deck coatings by light blast tracking to clean and provide a key which was followed by the application of Sika's Pronto system comprising of Pronto primer, sealer and waterproof coating to the deck.

The cracks and joints were banded with extra layers of Pronto 15 base coat and fleece, to bridge and waterproof the cracks.

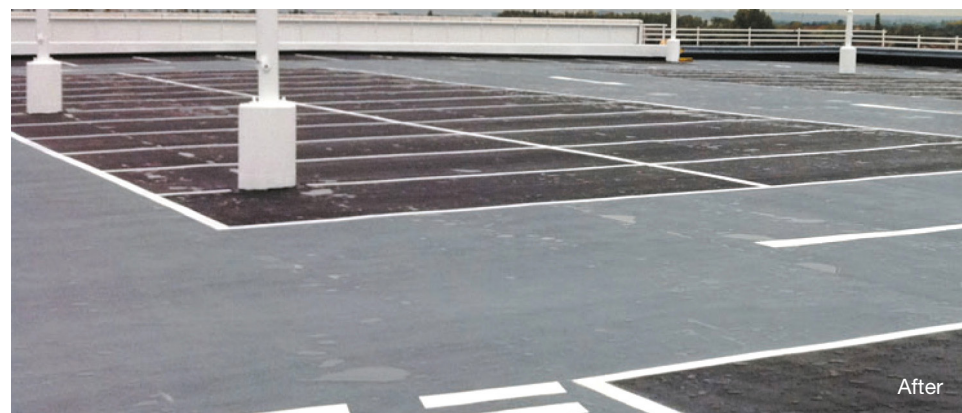
After

Different colours of the Pronto system were used to demarcate the areas between parking bays, and pedestrian areas to create Black parking bays, and Grey running aisles. Cemplas also undertook the reinstatement of the line marking in white.
