Case Study // Car Parks //

Retail Shopper Car Park Refurbishment

Morrisons Store Rooftop Car Park, Herne Bay, Kent

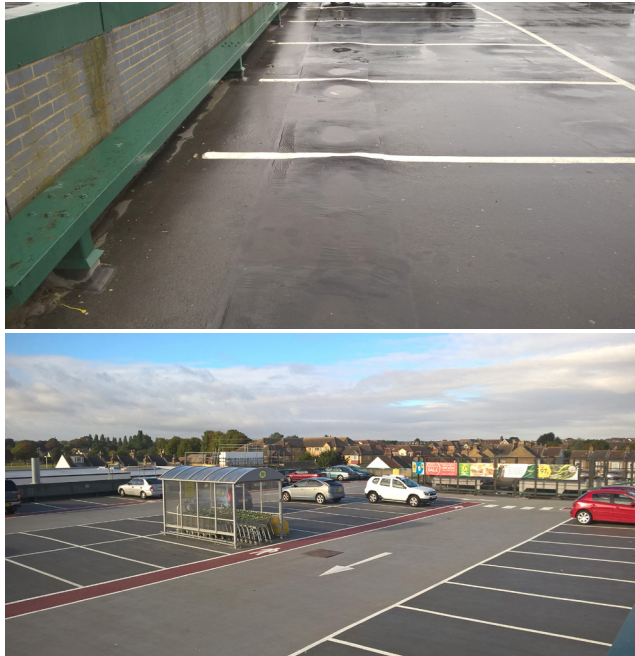
Before: Asphalt Waterproofing

After: Asphalt Waterproofing

The existing asphalt waterproof wearing surface of the car park had become badly damaged and split over the years and was allowing significant water ingress

into the store below. The asphalt itself – covering some 2,500m² – was prepared by planing & captive blast to remove surface imperfections & linemarkings and to provide a suitable mechanical key for the application of a new waterproofing system on top.

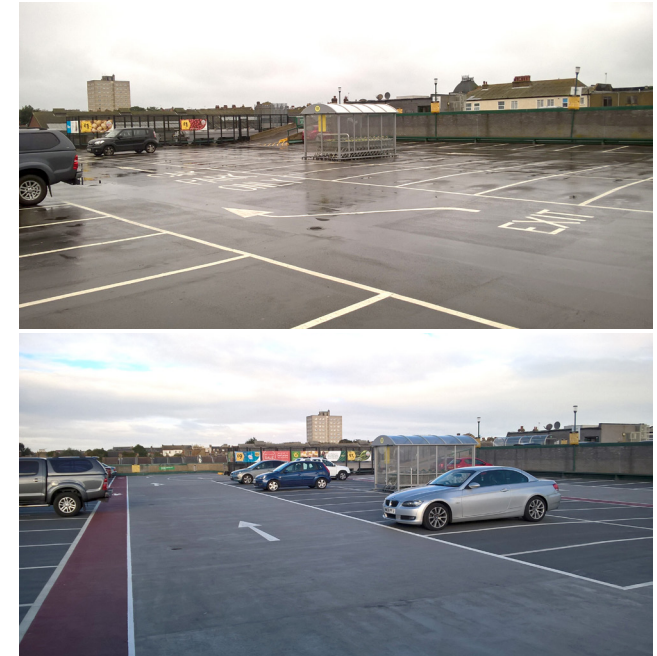
Before: Concrete Repairs

After: Concrete Repairs

Sika's fully-reinforced Pronto 32 system was applied to all areas including up / down ramps. Cemplas also carried out localised concrete repairs to the semi-circular vehicular access ramp.
