## £300,000 Facade Refurbishment

Olympia Exhibition Hall Façade, London

# Case Study //

## Concrete Repair & Protection

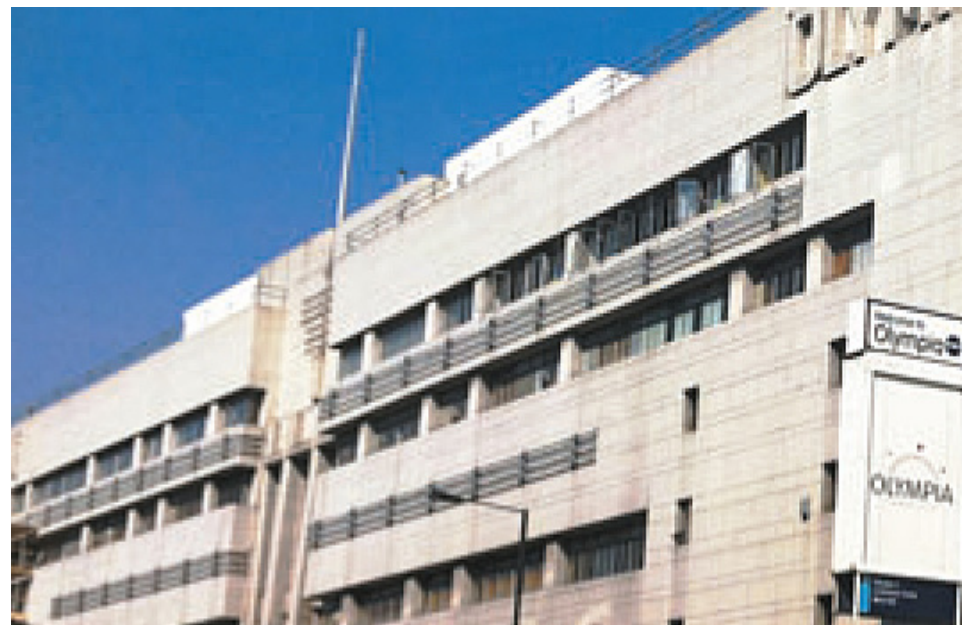
Works by Cemplas commenced by removal of the existing coating which had failed and was delaminating. Coatings were removed using DOFF, and Tensid Tavec 201 biodegradable coating removal system. This was followed by hammer-testing the concrete and reconstituted stone substrate to establish the extent of remedial repairs required.

All joints to the stonework were raked out and re-instated with a Geocel sealant. Repairs were carried out to the existing concrete cladding panels covering the building frame using Remmers Betofix RM Mortar. Isolated areas of the façade were treated using Remmers Elasto-flex façade fine filler and fairing coat, including re-scribing Ashlar lines.

Priming and coating were carried out with Remmers Elastoflex façade coating. In addition to the façade works Cemplas also carried out repairs and coatings to the canopy roof, and undertook the weathering details to the upper roof by applying Sika's Liquid Plastics Decothane Roofing Membrane.
