Liquid-applied Roofing

Tufnell Park Mansions, London

Case Study // Roofing

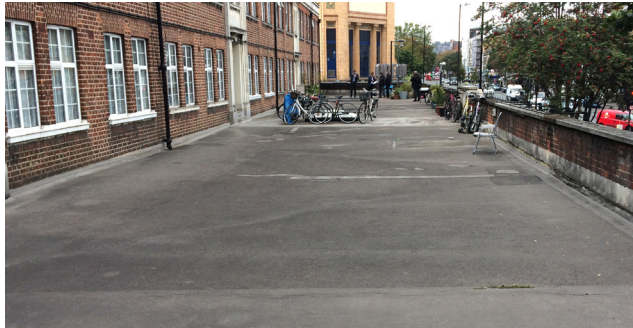
Before: Balcony Walkway Resurfacing

The existing waterproof wearing surface above the shops had many defects resulting in water ingress into the retail units below. Cemplas' works were to prepare and repair

the substrate by mechanical abrasion and power washing ready for the application of IKO's Polimar FCS Balcony and Walkway system. Chosen for its speed of cure to minimise inconvenience to residents while the new slip-resistant and waterproof surface was applied, Polimar primer, FCS detailing and wearing course were applied. Slip resistance was provided with Polimar aggregate
