Warehouse Floor Slab Repair

Sainsbury's Distribution Centre

Case Study // Flooring

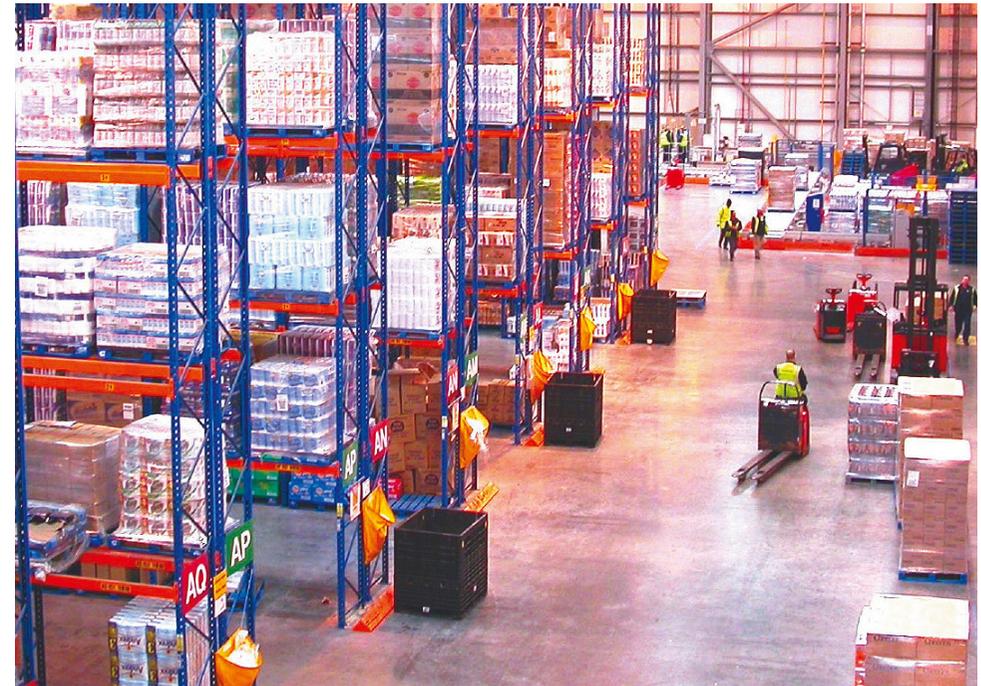
The work to both sites required Cemplas grinding 1895lm of cracks in the floor slab to a width and depth of 7mm and repairing with Webber E.P and replacing 1033lm of old failed joint sealant with Arbokol two-part epoxy polysulphide sealant.

Cemplas were also tasked with the removal of over 13,000 redundant bolts in the floor slab. Once the bolts had been removed these areas were repaired with an epoxy resin mortar, and careful grinding of the floor to FM2 tolerances was carried out to receive the new racking aisles. Scabbled floor areas were also cut out and repaired along with the door thresholds.
