Car Dealership Rooftop Parking

Audi Milton Keynes

SCOPE

Case Study //

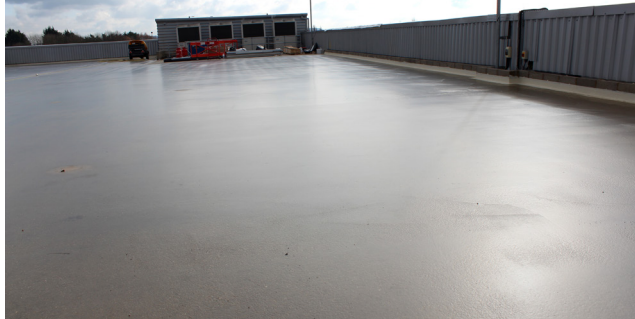
Before: Re-waterproofing Top Deck

of the existing roof deck from inadequate design. The replacement comprises a hollow-rib RC slab construction measuring some 1100m², waterproofed using Tremco's fibre-reinforced, rapid curing MMA (methyl-methacrylate) deck waterproofing system. The new deck provides 66 rooftop parking spaces, accessed via an incline ramp, also re-waterproofed

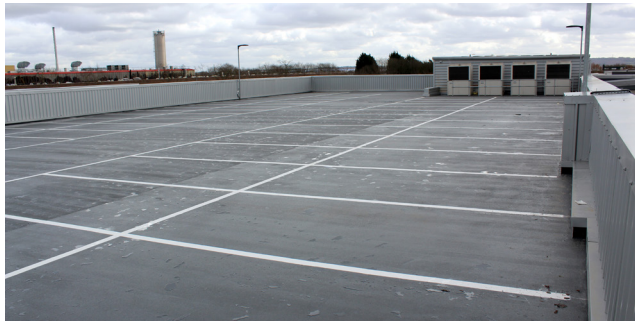
After: Re-waterproofing Top Deck

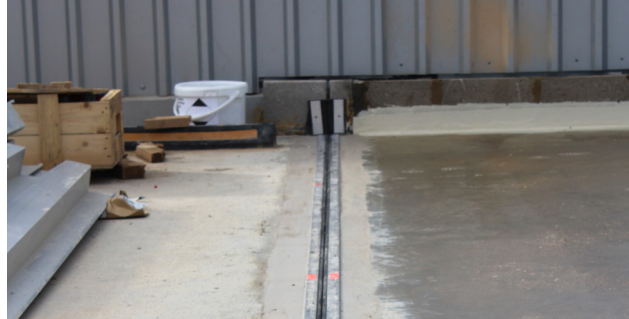
Before: Mechanical Movement Joint

using the same system (400m²). The new design also incorporated the need for a mechanical movement joint in the roof deck for which Cemplas installed Tremco's Migua jointing system.

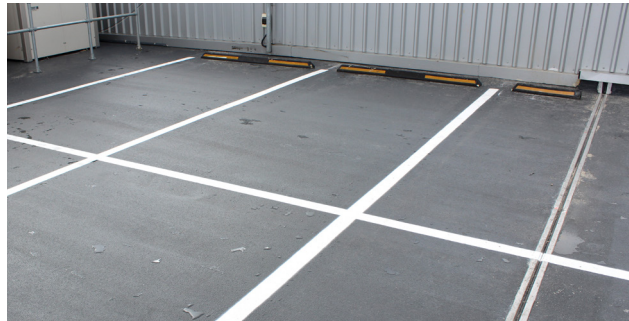
After: Mechanical Movement Joint

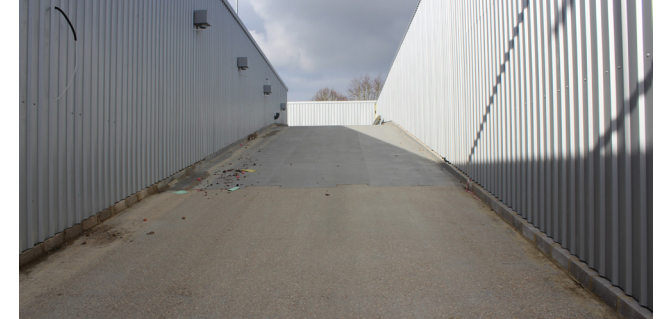
Before: Re-waterproofing Access Ramps

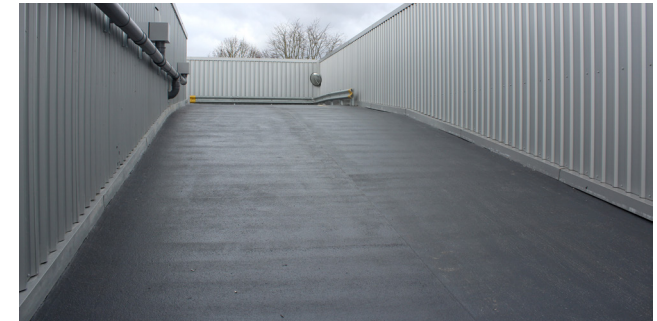
After: Re-waterproofing Access Ramps
