7 Week Multi-Storey Car Park Refurbishment

Meadows Retail Short Stay MSCP, Chemsford

Case Study // Car Parks

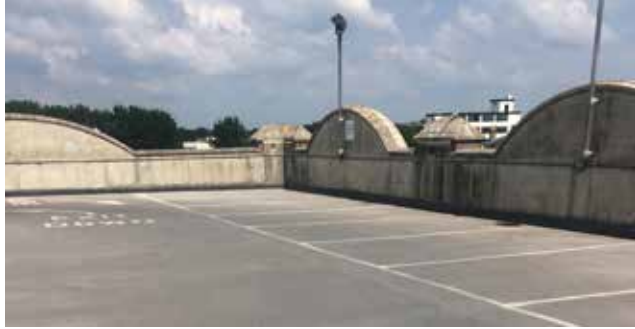
Before: Deck Waterproofing and Linemarking

Following surface preparation and repairs, Sika's migratory corrosion inhibitor was applied to all 7,200m² of internal decks followed by the application of Sika's Pronto 18 rapid-curing deck waterproofing system. Sika's anti-carbonation coatings were applied to approximately

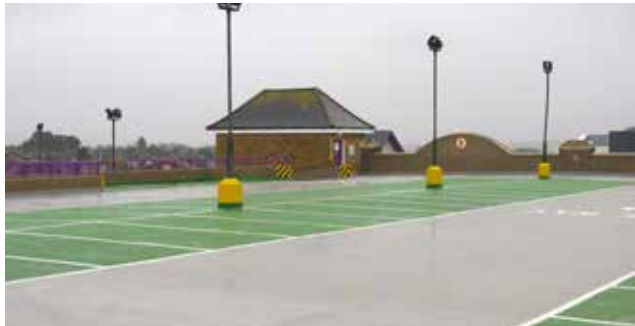
After: Deck Waterproofing and Linemarking

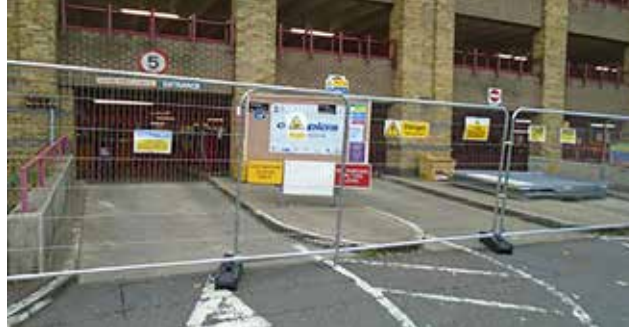
Before: External Decoration and New Signage

rather than having to remove and replace the existing damaged asphalt layer. The stairwells were completely refurbished along with the external façade metalwork and signage was upgraded throughout.

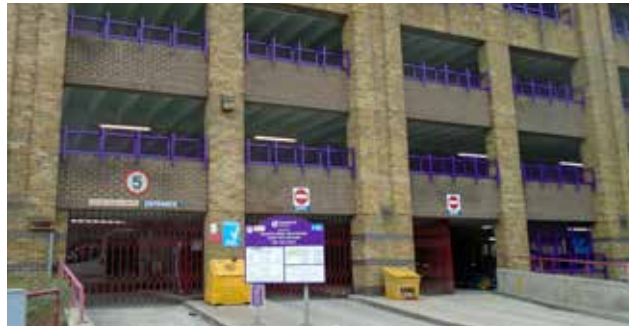
After: External Decoration and New Signage

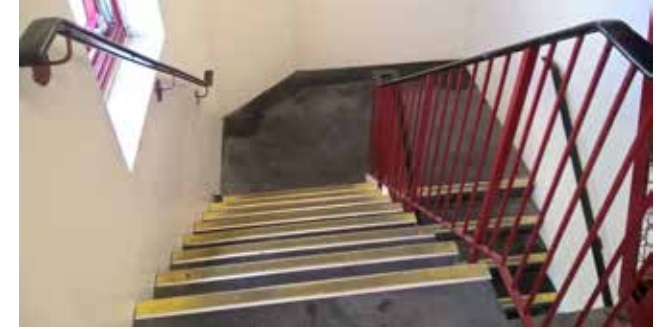
Before: Stairwell Refurbishment

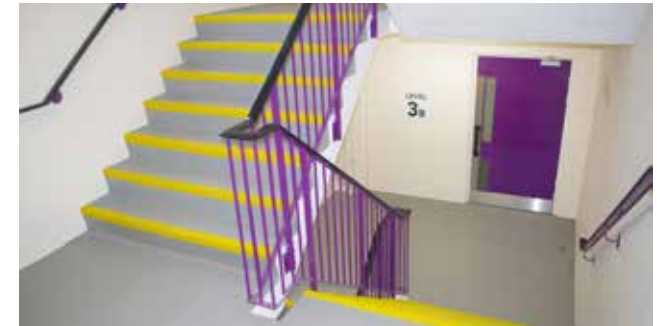
After: Stairwell Refurbishment
