Case Study // Car Parks //

Commercial Office Refurbishment Parking

200 Berkshire Place, Winnersh, Berkshire

- // Commercial office car park
- // Tremco rapid-curing methyl-methacrylate decking system
- // Ramps re-waterproofed

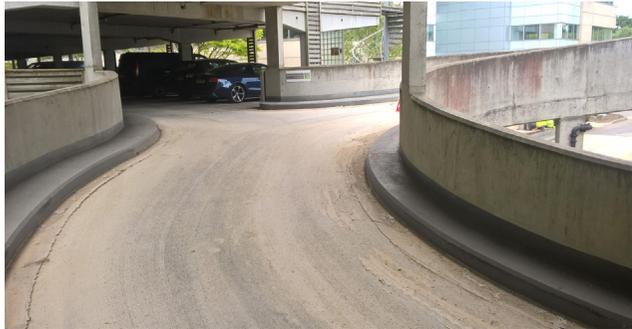
Before: Ramp Waterproofing

It was upgraded 17 years after having been originally waterproofed by Cemplas using a Tremco deck waterproofing system in 2000 when first constructed.

The decking works were carried out in two sections allowing half of the spaces to remain in use during works. The ramps at either end of the car park had to remain open constantly and were re-waterproofed outside of office working hours.

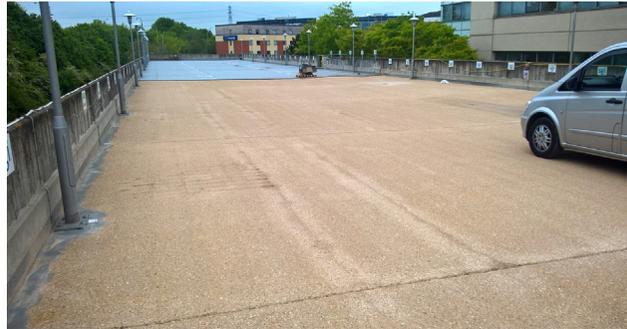
Before: Deck Waterproofing & Line Marking

The existing Tremco waterproofing had reached end of service life and required replacement. Given the client's primary requirement to keep any disruption from works to an absolute minimum, Tremco's latest rapid-curing methyl-methacrylate decking system was specified.
