## Case Study //

### Concrete Repair & Protection //

### Render Repairs Earls Court, London

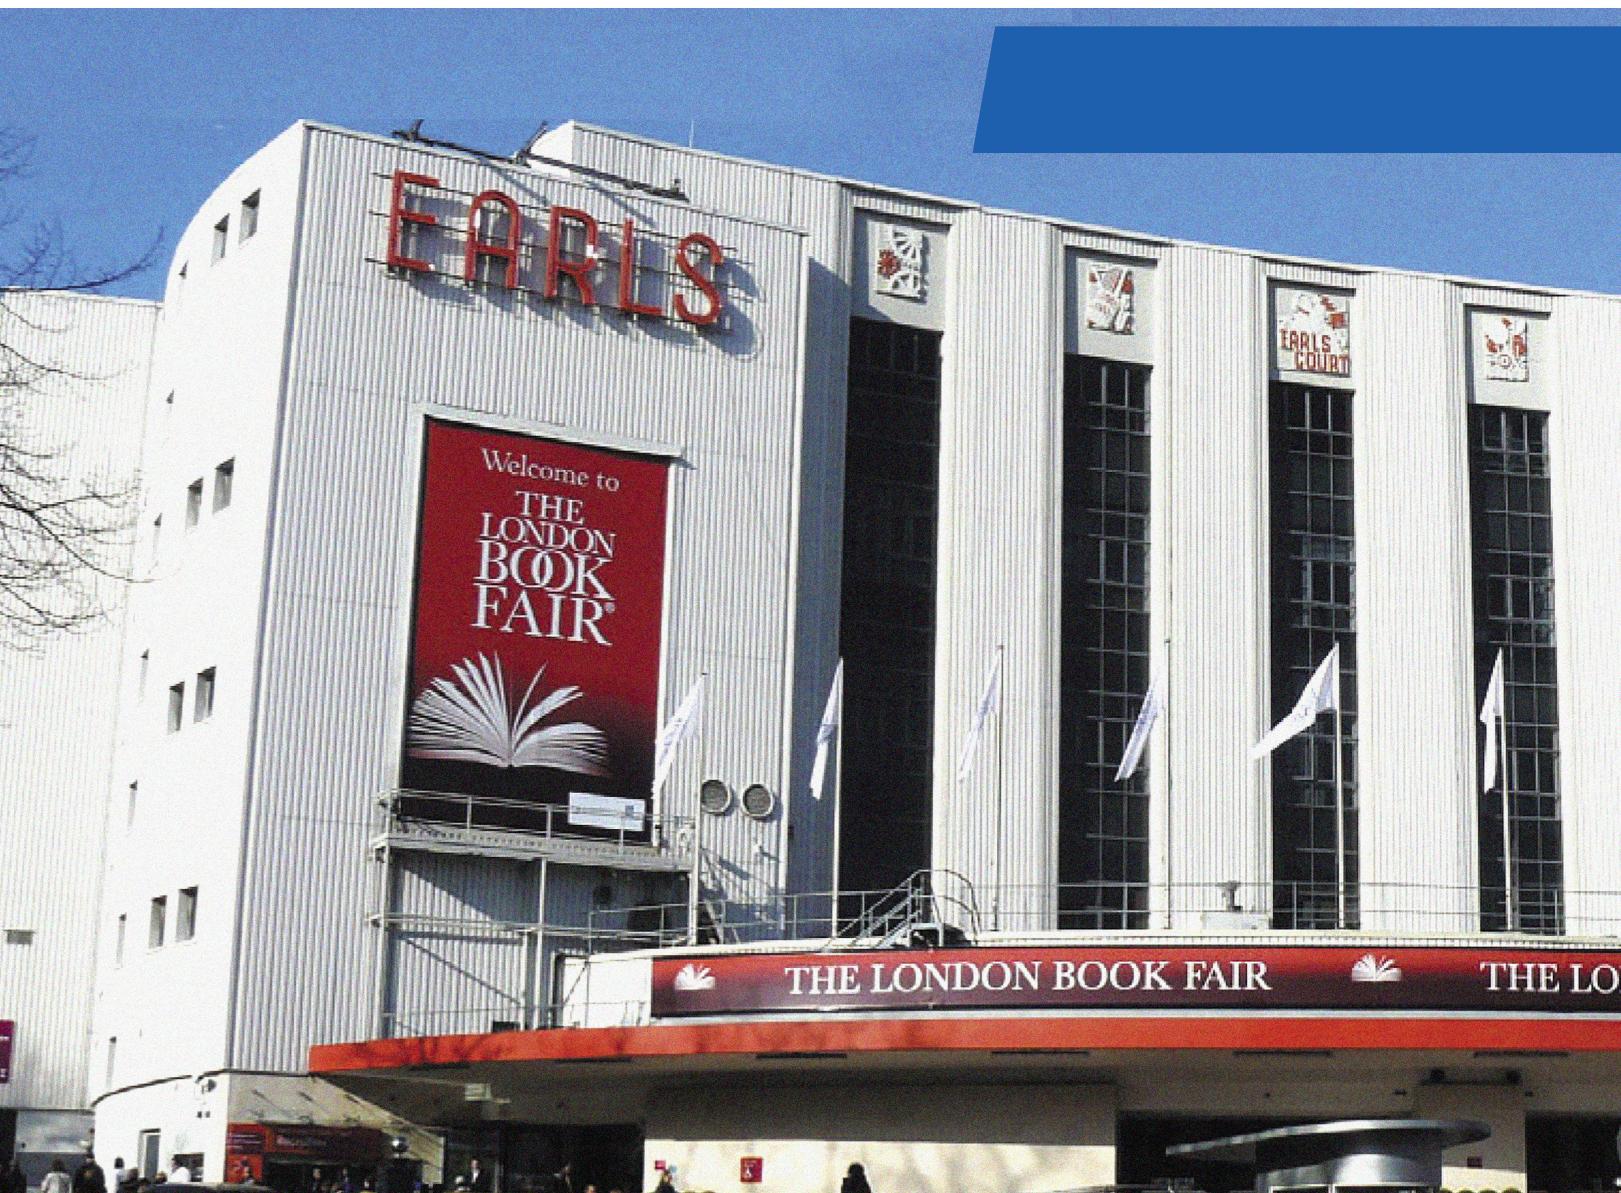
- // Rendered panels on front elevation of exhibition centre
- // Panels hammer-tested
- // Defective render removed
- // Specialist polymer render applied to panels
- // Decorative/protective paint coating applied

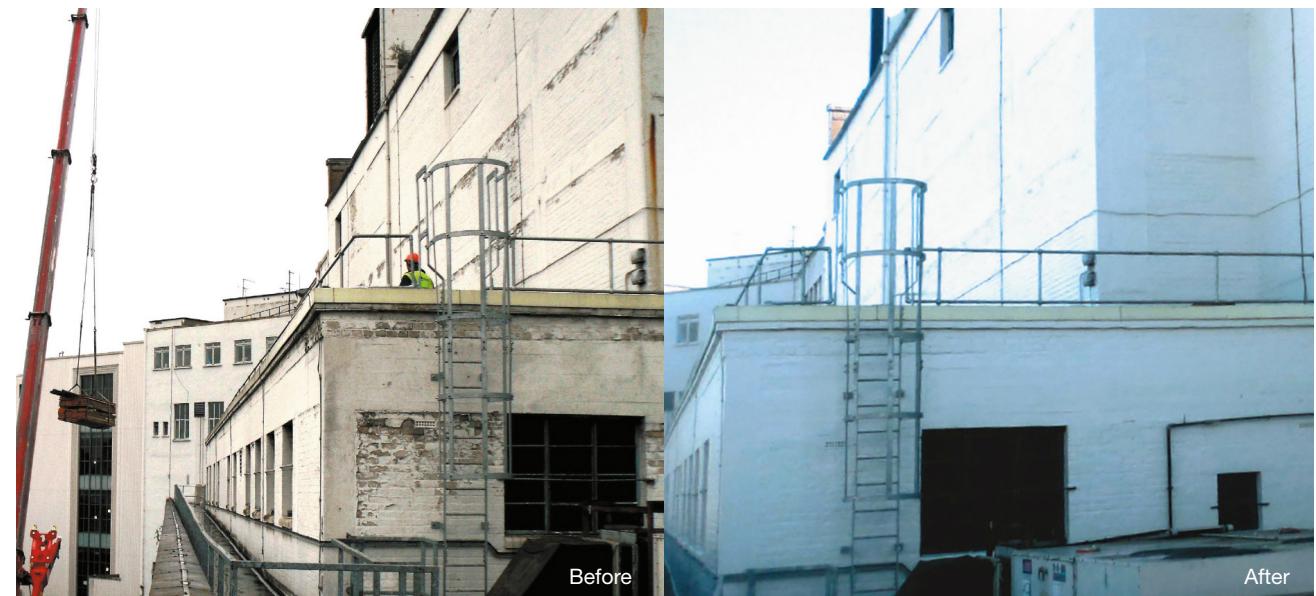
Recently Cemplas were called in to inspect and provide a quotation for render repairs and coatings to the rendered panels on the front elevation of the exhibition centre. Cemplas provided a lump sum quotation and were appointed to undertake the works as principle contractor.

Due to the location of the failed render, it was agreed the most cost effective manner to undertake the works was by Industrial Rope Access.

work together is often based on the demands of specific projects. This strategy of in-house staff, and collaborative arrangements is key in an industry of limited resources and often unpredictable programmes enabling us to maintain the quality, delivery and service expected by our clients. The panels were hammer tested and defective render removed, and re-instated with a specialist polymer render, followed by a decorative/protective paint coating to match the existing colour.
