## Architectural Concrete Refurbishment

South Bank Centre, London

# Case Study //

## Concrete Repair & Protection

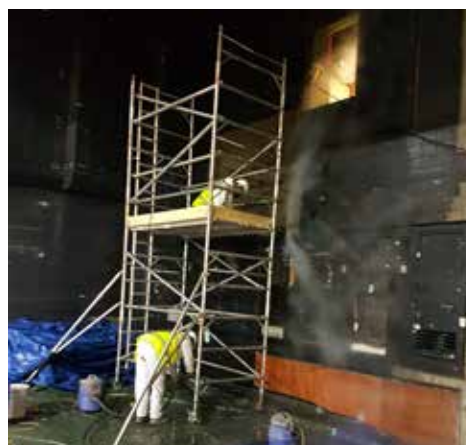
Before: Repair Works

Queen Elizabeth Hall, Hayward Gallery & Purcell Room have been restored to their original character including renovating board-finished concrete walls and coffered concrete ceilings. Remmers' Arte Mundit 'peelable' poultice was applied which, when peeled away, removed superficial dirt that had built up on the concrete. The rear walls of the Queen Elizabeth Hall stage also saw black paint removed using the 'Doff' method and Tensid Tavec 201 Biodegradable paint remover. Once cleaned, repairs have had to be carried out and blended in to ensure that they are not easily visible.

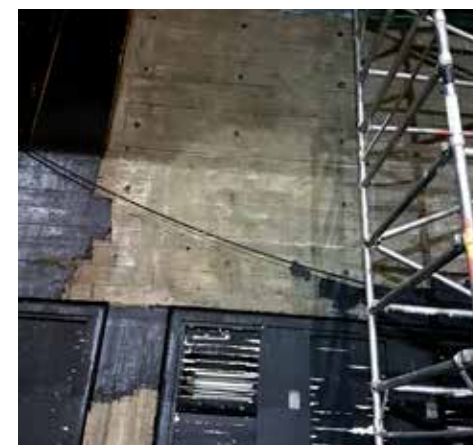
After: Repair Works

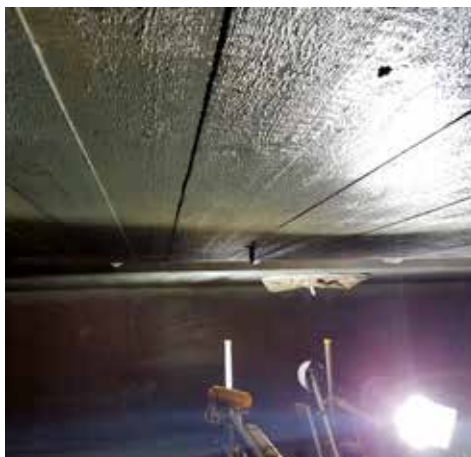
Remmers' Arte Mundit 'Peelable' Poultice

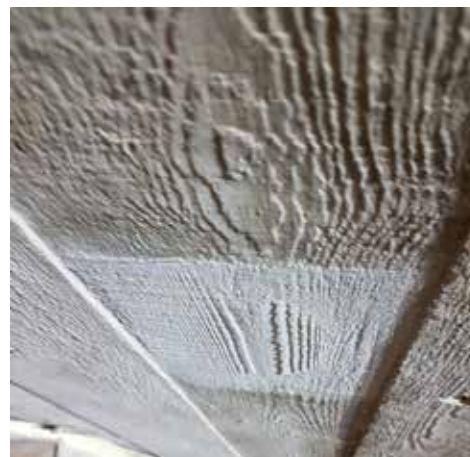
Blended Repairs

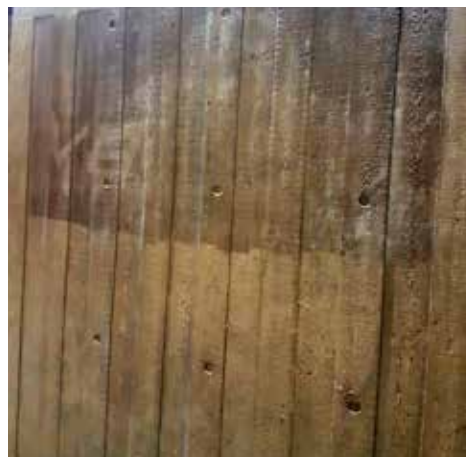
Cleaned Surfaces

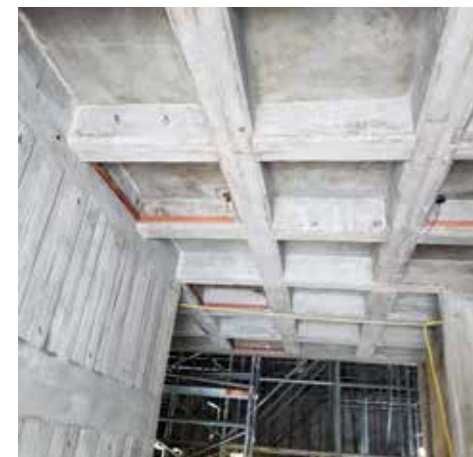
Hayward Gallery Cleaned
