## Dome Roof Waterproofing

Olympia Exhibition Centre

# Case Study // Roofing

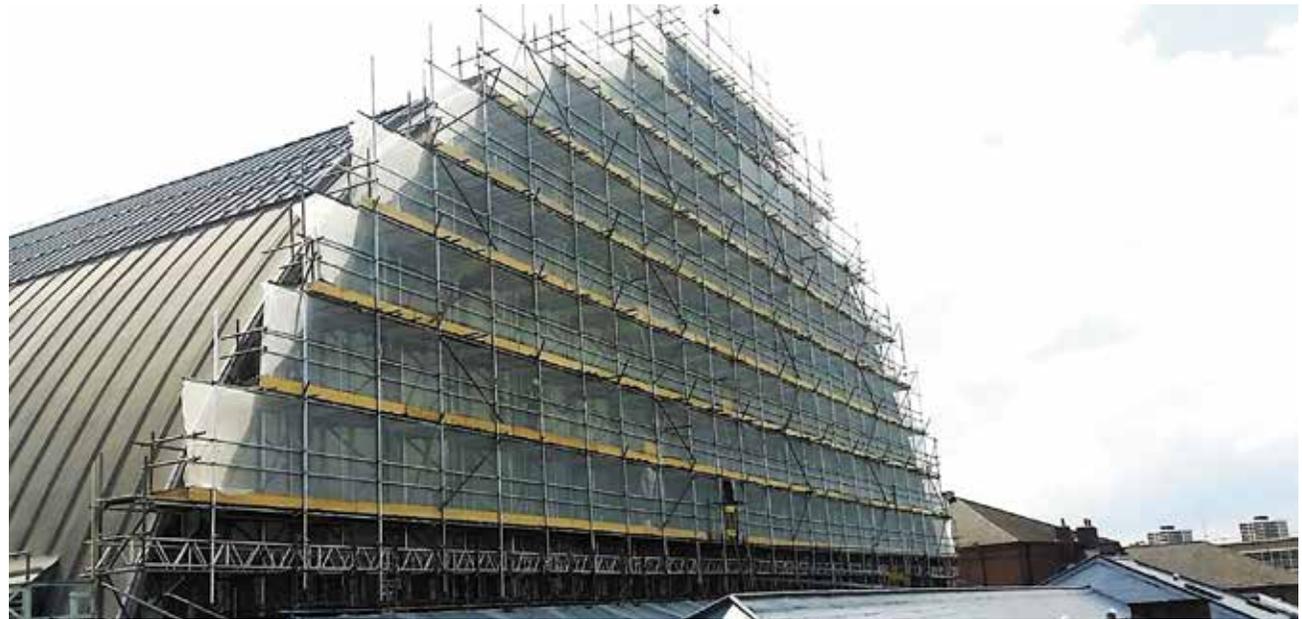
The first phase of works involved Cemplas applying a Waterproof coating over the venues 60-year-old asphalt flat roof. This year Cemplas undertook the second phase of specialist work on this iconic building waterproofing the original glazed dome roof above the exhibition hall which has leaked over the years, and was due to be completely re-glazed at an enormous cost.

Working closely with Olympias own in house Structural Engineer's and Surveyors, a specification and method was provided for a cost effective solution to apply a resin based 'clear' system over the glazed sections and glazing bars and re-glazing all the diamond

segments, chemical stripping the steel beams and repainting. Many of the projects undertaken at Olympia have had demanding access issues and in this instance Cemplas developed its own access arrangements by providing a scaffold which was built up from within the Exhibition Hall and cantilevered out.

- // Waterproofing original glazed dome roof above exhibition hall
- // Application of resin based 'clear' system over glazed sections and glazing bars
- // Re-glazing diamond segments
- // Chemical stripping steel beams and repainting
