Flat Roof Waterproofing

Oxted Residential Flats

Case Study // Roofing

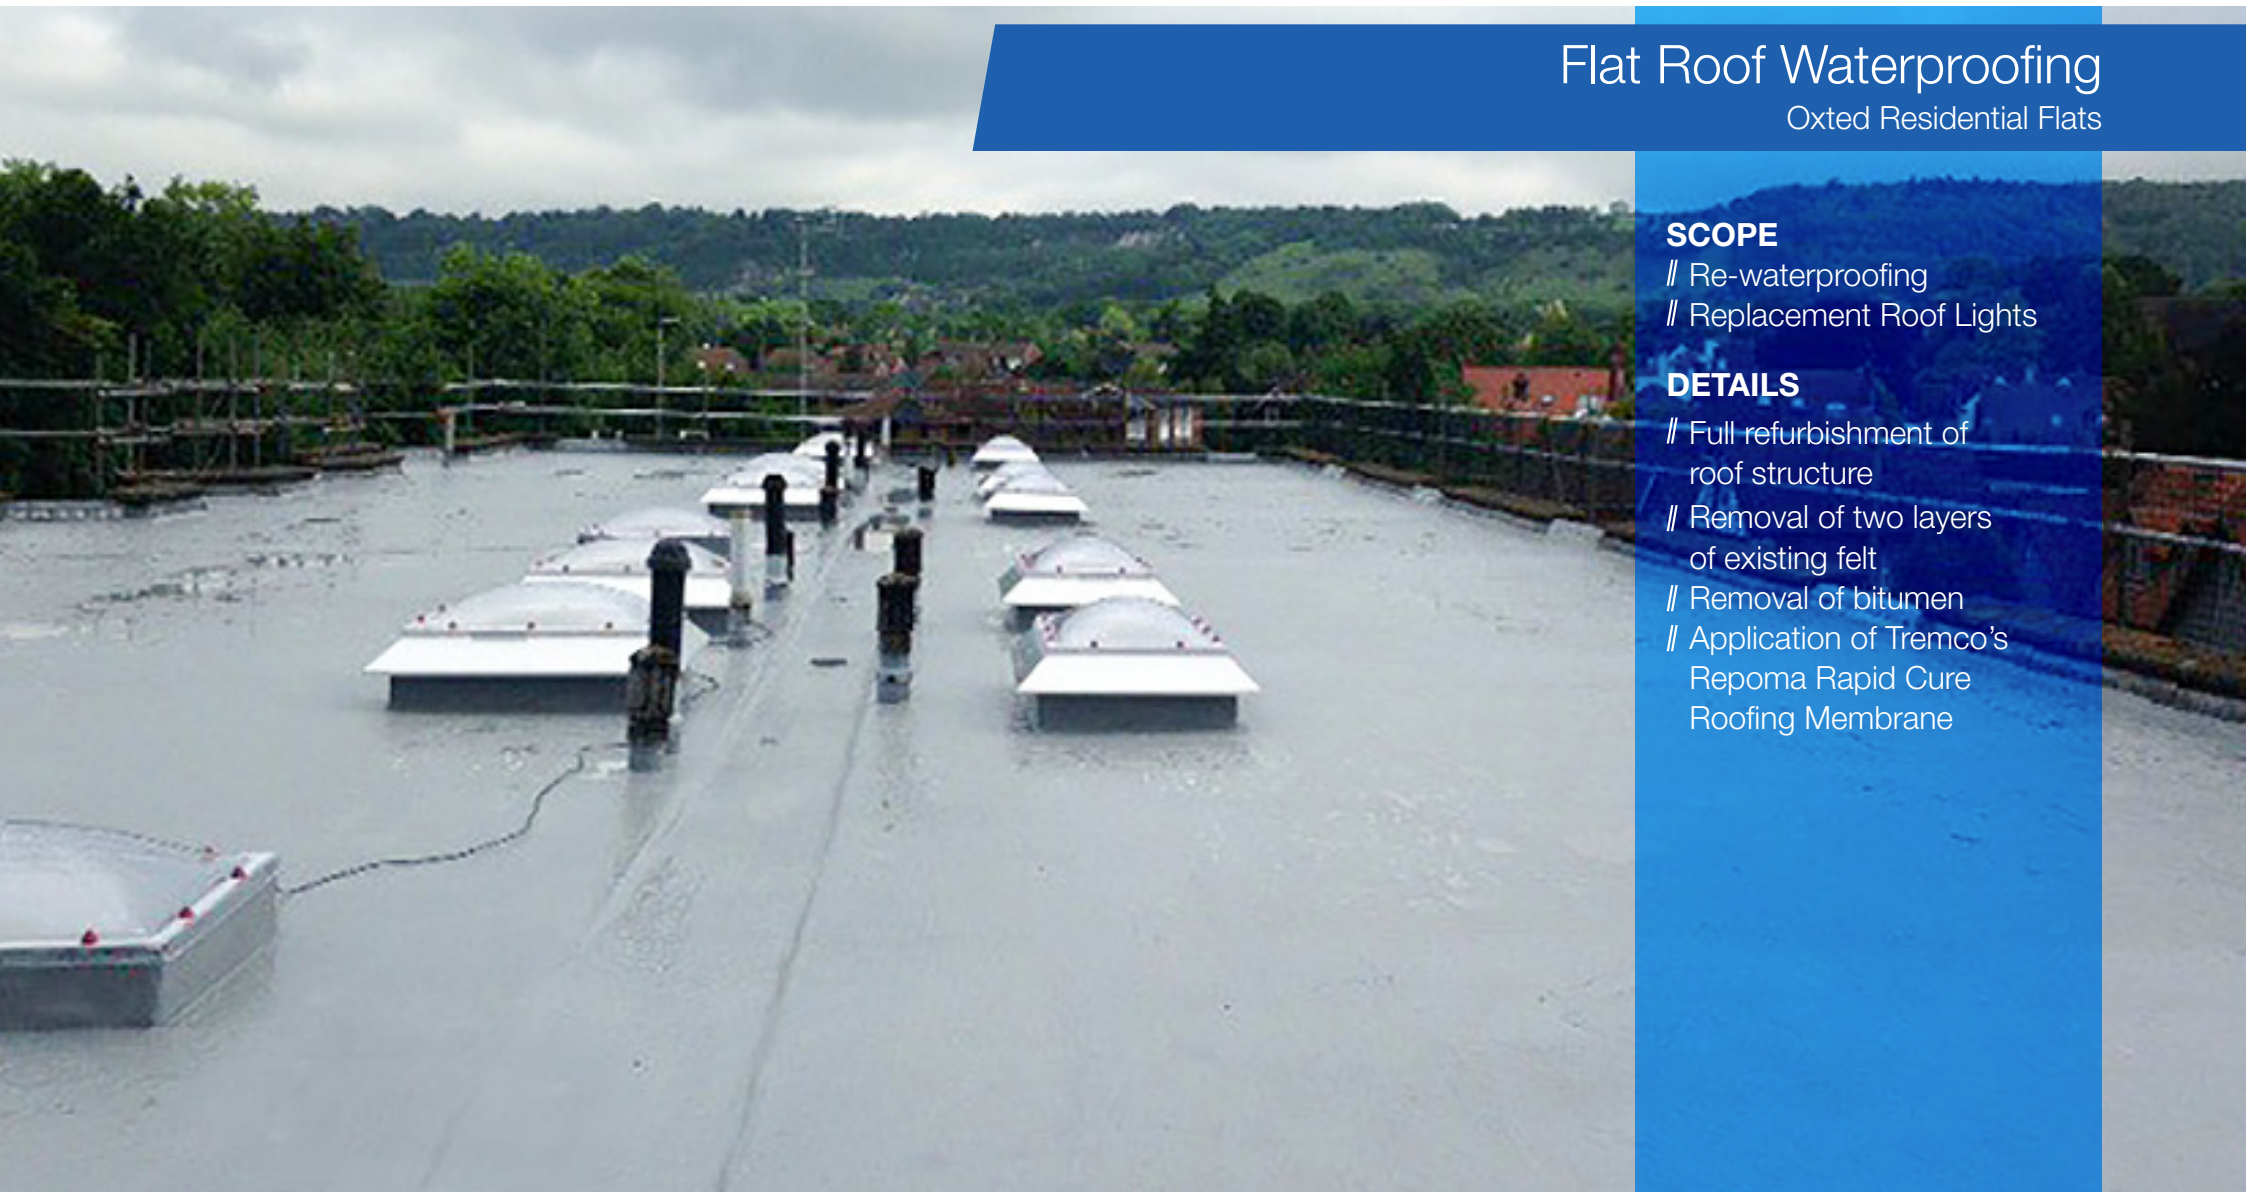
- // Full refurbishment of roof structure
- // Removal of two layers of existing felt
- // Removal of bitumen
- // Application of Tremco's Repoma Rapid Cure Roofing Membrane

The works included the removal of two layers of the existing felt, recovery board and preparation of the asphalt to remove bitumen and provide a suitable surface for the roof system by grinding. Following the preparation works, Cemplas operatives applied Tremco's Repoma Rapid Cure Roofing Membrane which is a highly elastic membrane based on PUMA technology, with excellent crack bridging performance, and was the ideal repair, renovation and waterproofing roof system for this particular project. During the project Cemplas also removed the roof lights and replaced with new ones.
