## Liquid-applied Roofing

Tufnell Park Mansions, London

# Case Study // Roofing

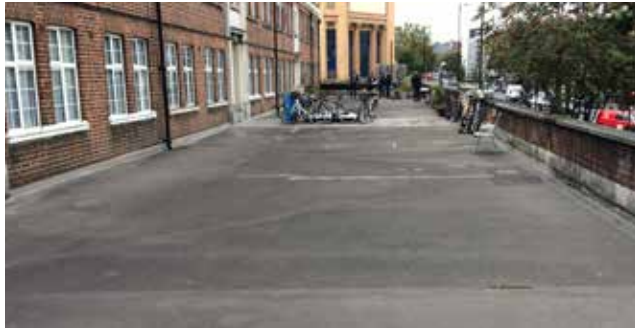
**Before:** Balcony Walkway Resurfacing

The existing waterproof wearing surface above the shops had many defects resulting in water ingress into the retail units below. Cemplas' works were to prepare and repair

the substrate by mechanical abrasion and power washing ready for the application of IKO's Polimar FCS Balcony and Walkway system. Chosen for its speed of cure to minimise inconvenience to residents while the new slip-resistant and waterproof surface was applied, Polimar primer, FCS detailing and wearing course were applied. Slip resistance was provided with Polimar aggregate

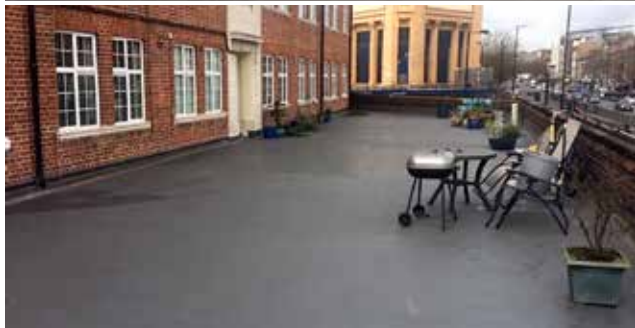
**After:** Balcony Walkway Resurfacing

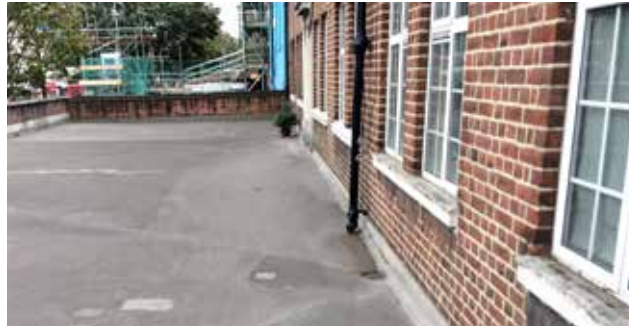
**Before:** Slip-Resistant and Waterproof Surface

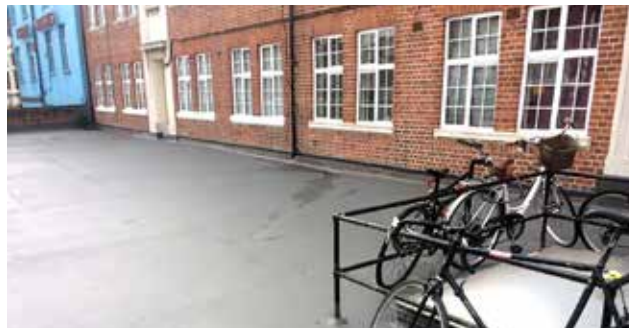
**After:** Slip-Resistant and Waterproof Surface

followed by FCS Sealer Coat. Works were carried out over a short programme as the terraces are the only means of access for residents.

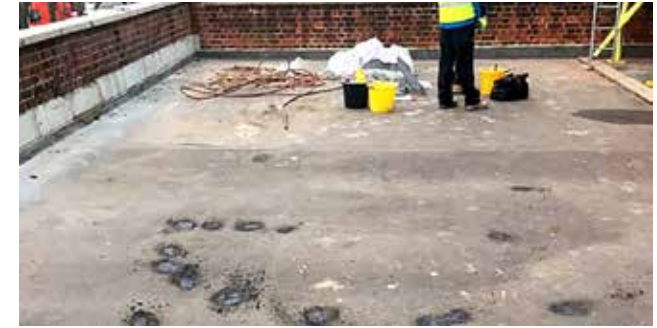
**Before:** Repair Substrate by Mechanical Abrasion

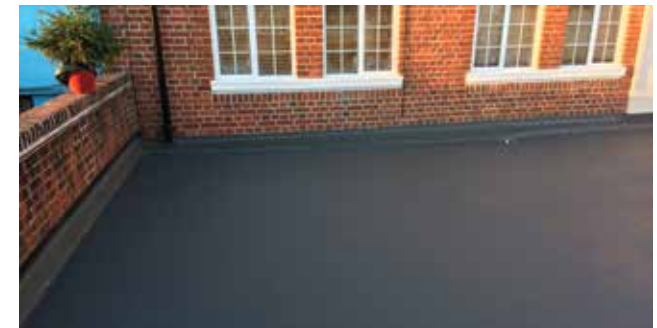
**After:** Repair Substrate by Mechanical Abrasion
