## Staircase Concrete Repairs

Cressy House, Whitechapel

# Case Study // Flooring

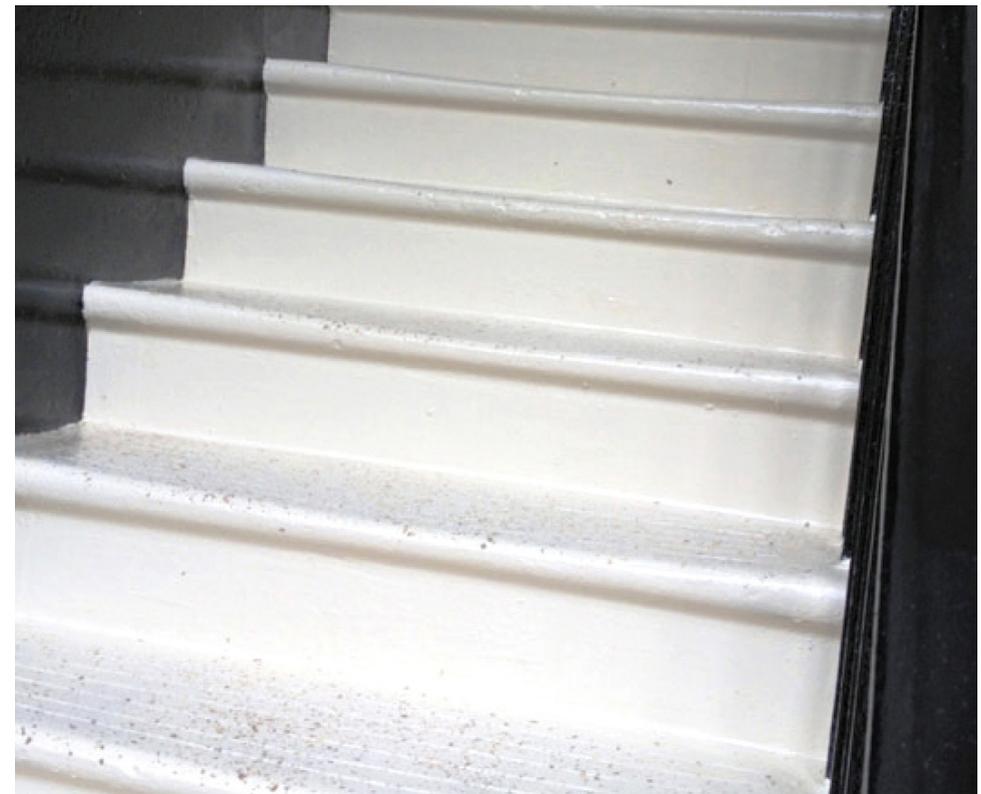
A survey by Cemplas revealed cracks to the treads and risers, and also to the floor landings. These cracks had led to water penetration which in turn had caused spalling of the concrete at the base of the metal railings, and led to failure of the existing floor coating. The survey also found defective concrete to varied areas of the staircase soffits where water had penetrated through causing the concrete to spall.

Work commenced by grinding out all cracks and reinstating the profile with a polymer modified repair mortar. Spalled areas of concrete were broken out, and all steel reinforcement cleaned and primed prior to reinstating with the repair mortar.

Due to the narrow width of the staircases, Cemplas were unable to undertake the work in two halves, and specified the use of the Vulkem Quick Waterproof Floor Coating System incorporating decorative coloured flakes. This fast track coating allowed Cemplas operatives to commence work each day at 10am and fully complete the works each day by 4pm allowing the staircase to be re-opened to the residents and given full access with little or no disruption.
