Case Study Car Parks

Retail Shopper Car Park Refurbishment

Morrisons Store Car Park, Blackburn

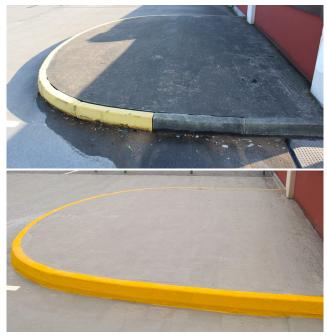
Before: Damaged kerbs

After: Protected & reinforced

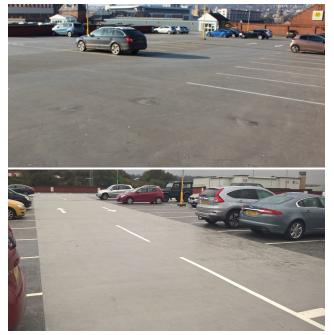
Given the nature of this car park's construction, there was reflective cracking in the top deck asphalt waterproofing

After: Decks re-waterproofed

along most of the beam lines which was allowing water ingress into parking levels below. This necessitated the application of a fully reinforced car park deck waterproofing system to ensure watertightness and prevent further damage.

The asphalt to the entire top deck and semi-circular inclined ramps was prepared through captive blasting followed by the application of Sika's fully reinforced and Client | Wm Morrison Supermarkets plc Role | Principal Contractor

rapid-curing RB58 deck waterproofing system. Once re-waterproofed, all linemarking, directional arrows & instructions to both the decks & ramps – measuring approximately 8,000m2 in total – were reinstated.

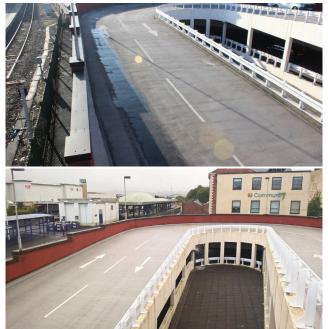
Before: Damaged asphalt on ramps

After: Ramps watertight
