Client | Wm Morrison Supermarkets plc | Role | Principal Contractor

Case Study // Car Parks

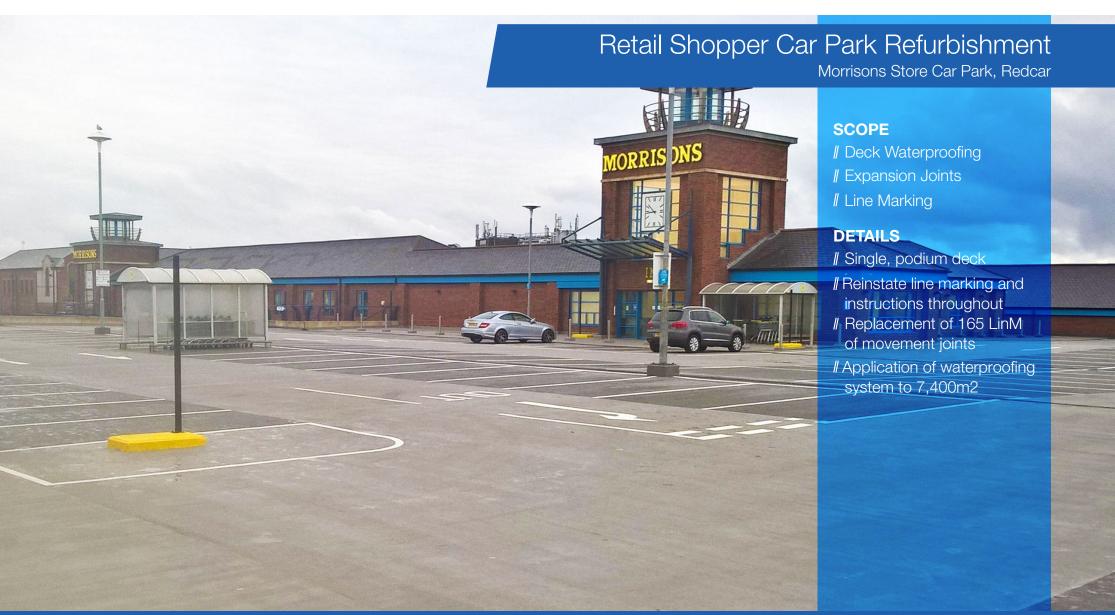
Before: Worn out waterproofing

The scope of this refurbishment was to replace the badly worn existing deck waterproofing system and mechanical joints to the upper deck, both of which had failed and were allowing water ingress across the car park leading to possible structure damage.

reinforced concrete planks simply supported within a RC frame. The structural 'topping' on top of the pre-cast planks was at risk of further damage given movement cracks which had formed and reflected through the waterproof decking system allowing salt-water ingress.

The entire surface area of the upper deck – measuring some 7,400m2 - was prepared by removing the existing waterproofing, replacing 165 LinM of movement joints and

followed by the application of Sika's RB28 car park decking system to re-waterproof. All works were carried out over a 14-week contract programme with phased possessions to reduce inconvenience to customers.
