Multi-Storey Car Park Refurbishment

Castle MSCP, Guildford

Case Study // Car Parks

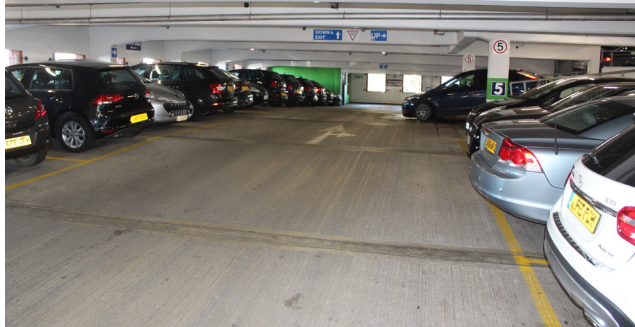
Before: Unprotected Concrete Decking

All 7,500m² of brush-finished in-situ concrete decks were prepared by captive shot blasting to remove surface contaminants and to provide a suitable mechanical key

for the subsequent application of protective coatings. A combination of Sika's RB24 & RB28 car park deck waterproofing system was applied to all six internal levels and inter-connecting internal ramps. This project was completed in phases to allow for continued use of the car park during opening hours thus minimising any inconvenience to the car park's users.

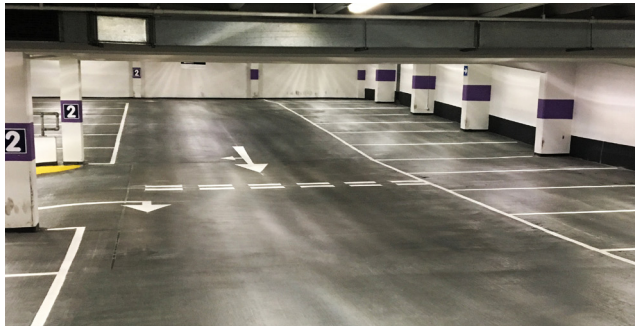
After: Fully Waterproofed Decks

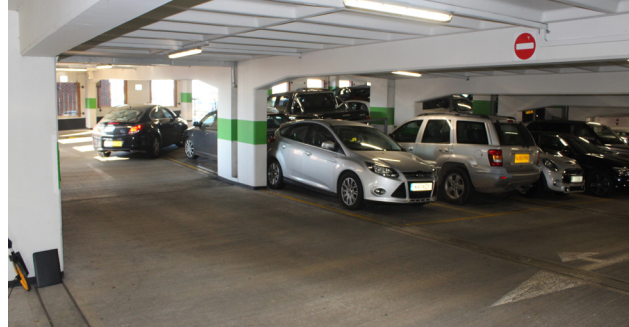
Before: Dark & Uninviting Interiors

The scope of this refurbishment was to upgrade and improve the overall aesthetic appearance within this comparatively new multi-storey car park whilst at the same time adding a coloured, protective waterproof coating to the parking decks throughout.

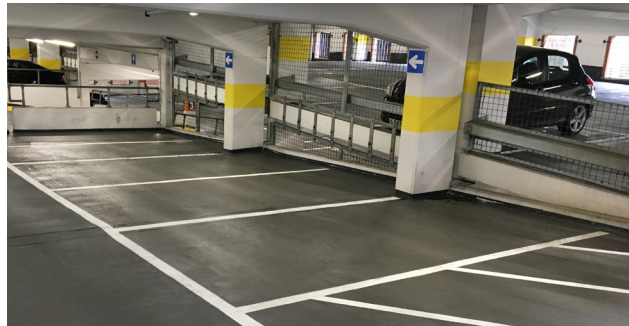
After: Light & Bright Interior Improvements

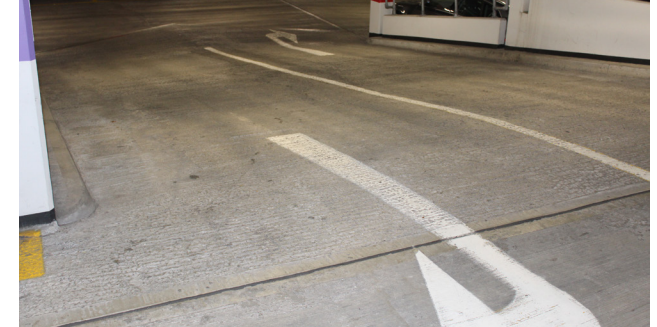
Before: Fading Line Marking

- // 7,500m² of deck waterproofing
- // Reinstate line marking and directional instructions
