Basement/Lower Ground Floor Waterproofing

Pitshill House, West Sussex

Case Study // Waterproofing

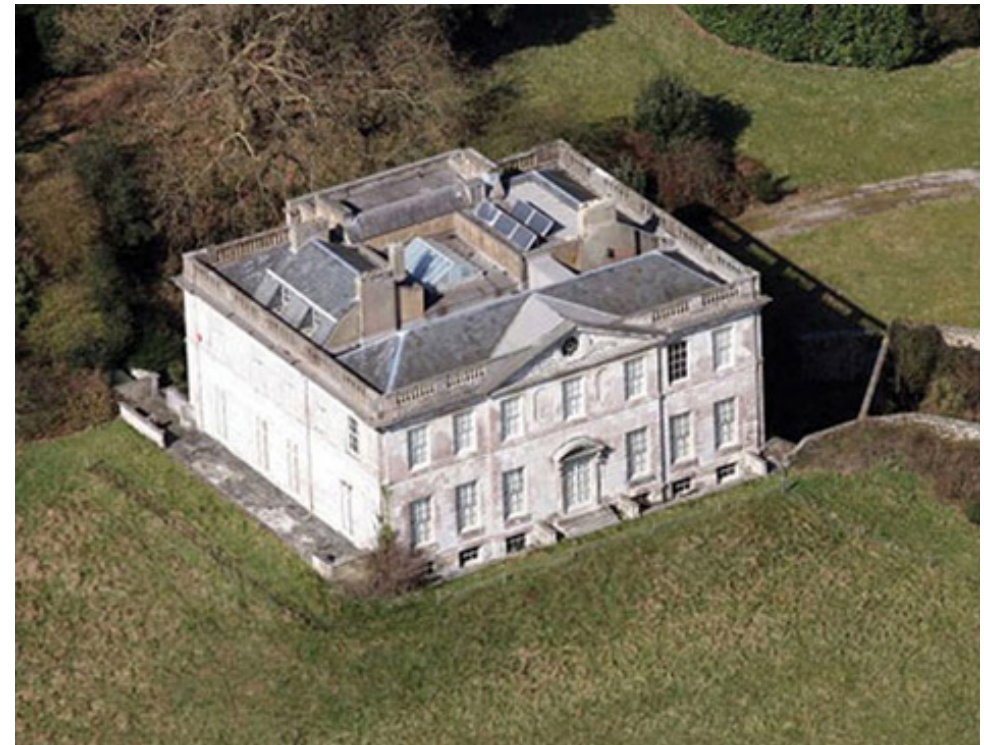
Cemplas installed Delta MS500 to the Basement walls, and loose laid Delta MS20 to all floor areas. The lower ground floor required Cemplas installing Delta MS500 to floors. Delta PT liner was installed to corridors, and Delta MS500 was installed to the remaining walls and fixed with Delta plugs. Work under this section consists of furnishing everything necessary for and incidental to the preparation, installation and completion of the Bituthene 3000 to the Plant Room Roof.

The extent of the works to the Plant Room Roof required applying Bituthene 3000 primed with Bituthene B1 Primer to all surfaces to all horizontal surfaces and returning vertically to the top and dressed into the roof outlet. Once applied the Bituthene membrane was protected against damage using Grace Protection 03 boards bonded to the membrane as a temporary measure using Bitustik 4000 double sided tape.
