Case Study // Car Parks //

Office Parking Cygnus House, Fleet

SCOPE

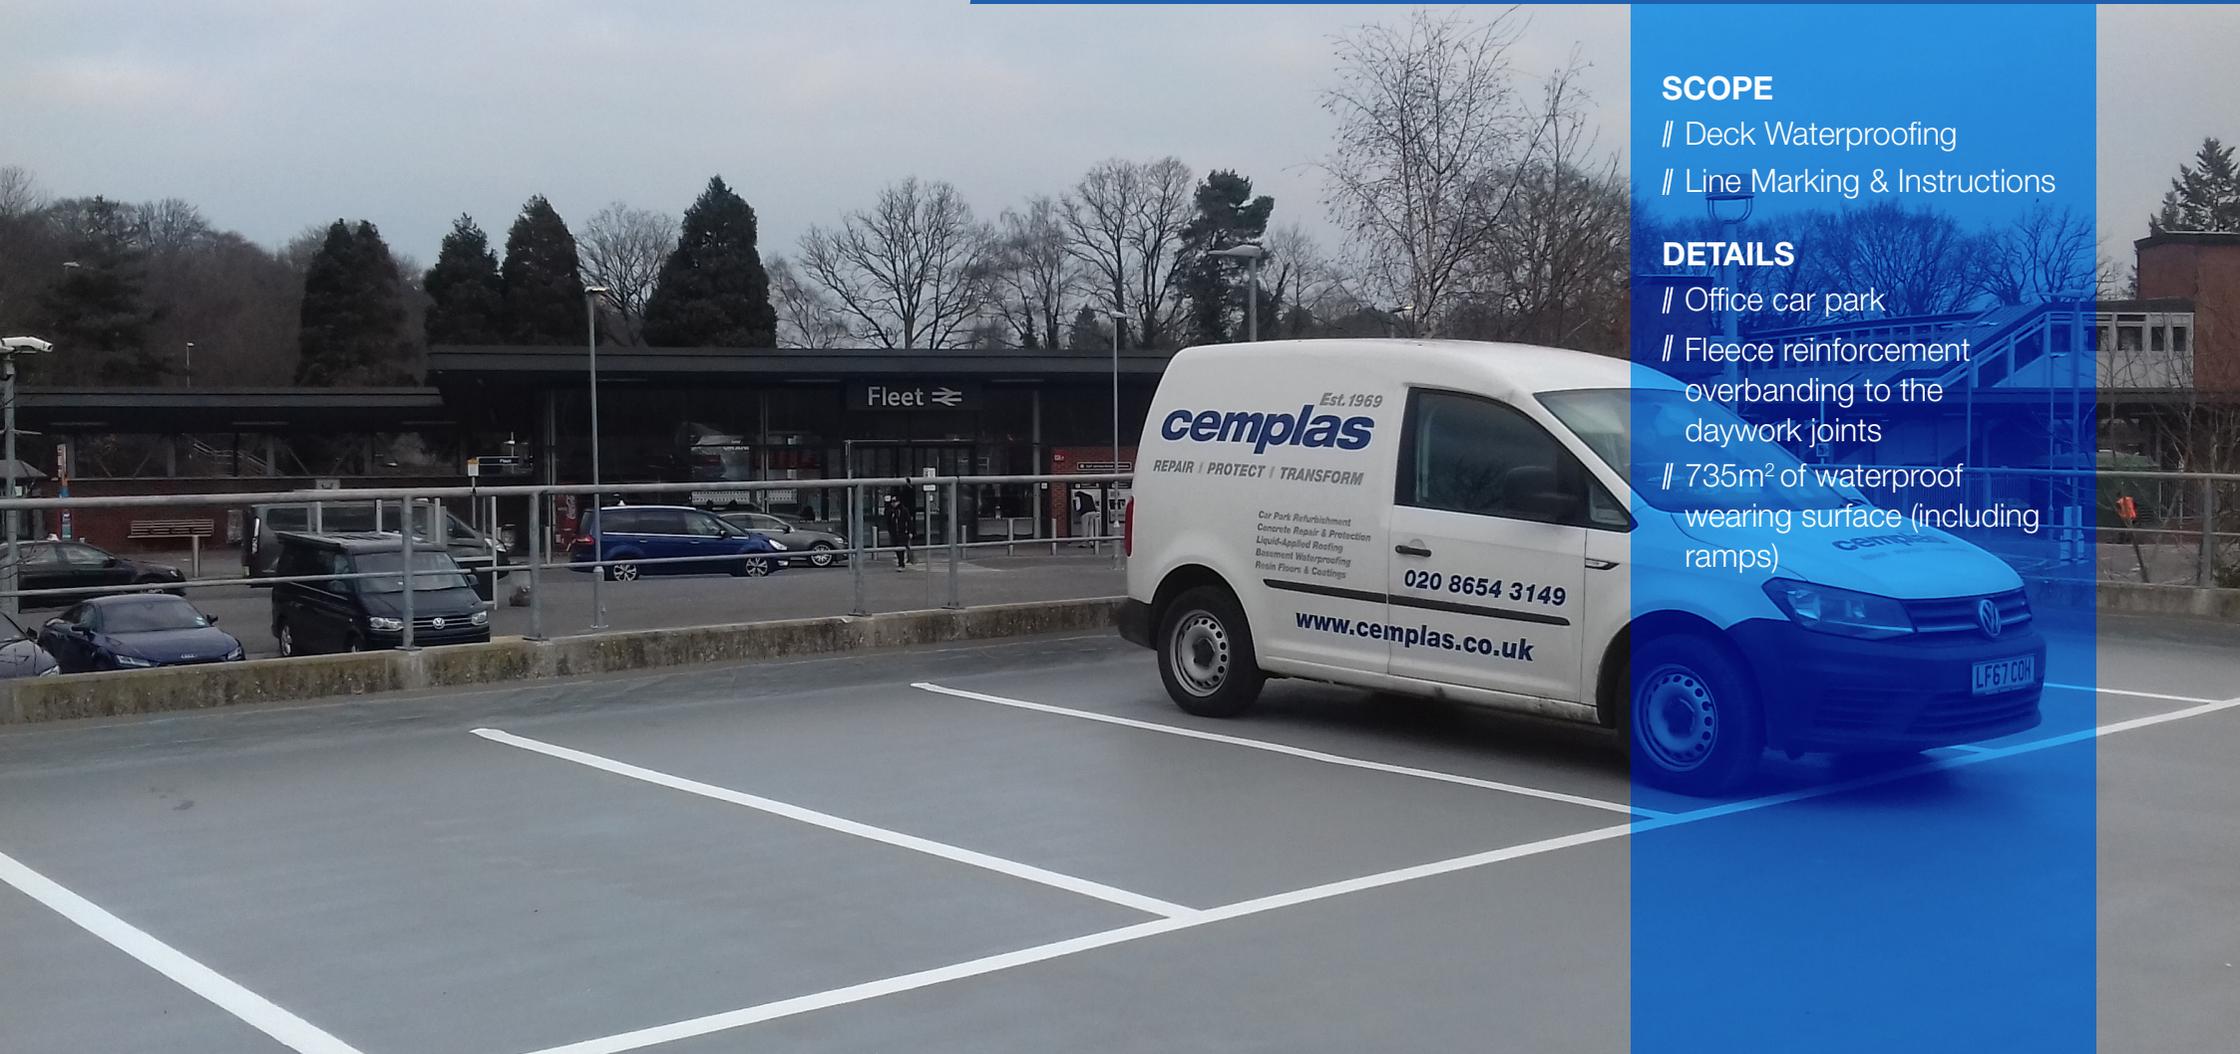
- // Office car park
- // Fleece reinforcement overbanding to the daywork joints
- // 735m² of waterproof wearing surface (including ramps)

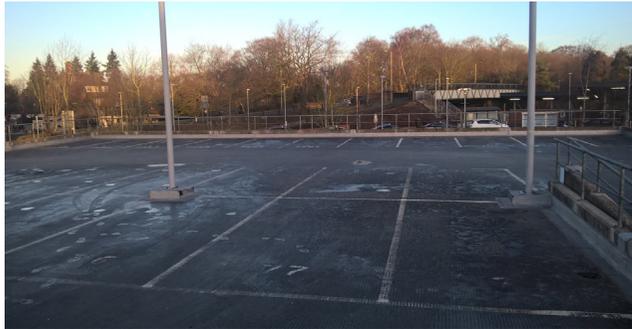
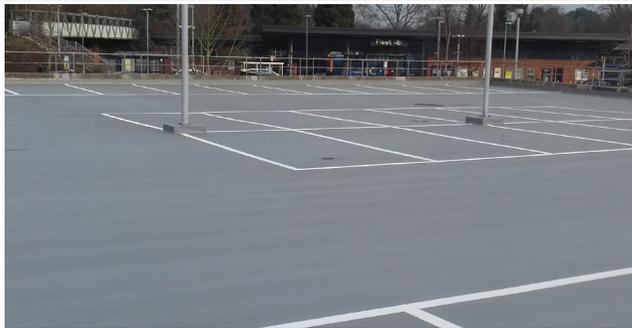
Before: Poor Quality Environment

After: Overall Surface Enhanced

The scope of this refurbishment was to repair and re-waterproof the existing surface including the split daywork joints, which had been leaking for some time.

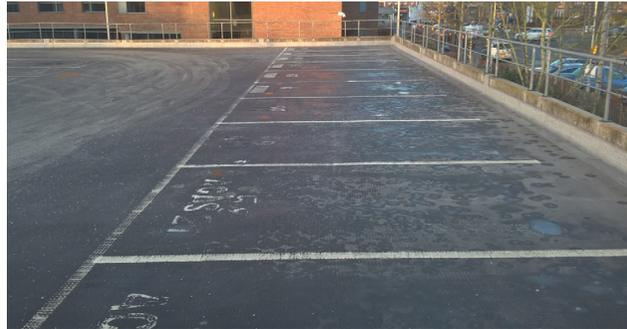
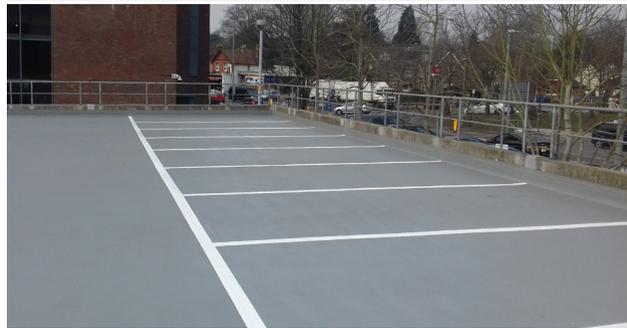
Before: Damage to Deck Surface

After: Fully Protected & Watertight Deck

Following substrate preparation which included captive blasting and line removal, wheel indents and other defects

in the existing asphalt surface were repaired incorporating Tremco's CP581 fleece reinforcement overbanding being used also to treat daywork joint splits.

Following minor drainage repairs and alterations, the top deck of the car park was fully re-waterproofed using Tremco's Rapid Cure MMA Deck Waterproofing System.

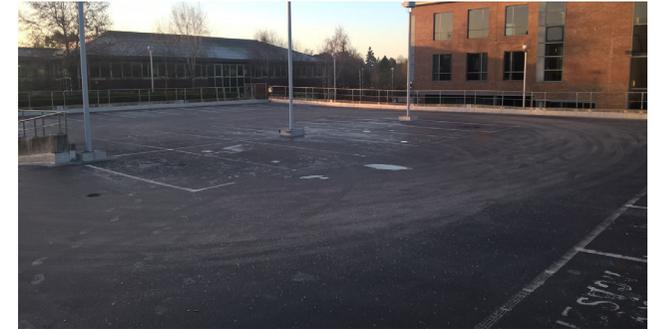
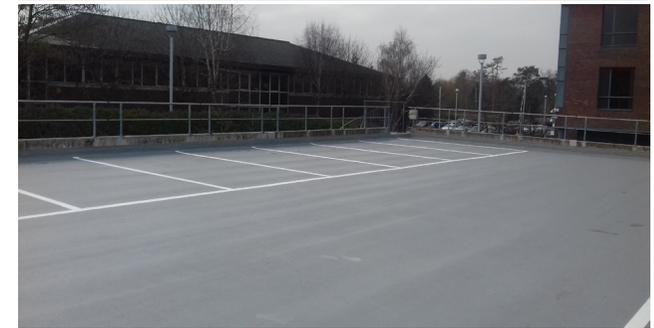
Before: Faded Line Marking & Instructions

After: Line Marking & Instructions Reinstated
