Office Car Park Refurbishment

EDF Energy, Bexley Heath

Case Study // Car Parks

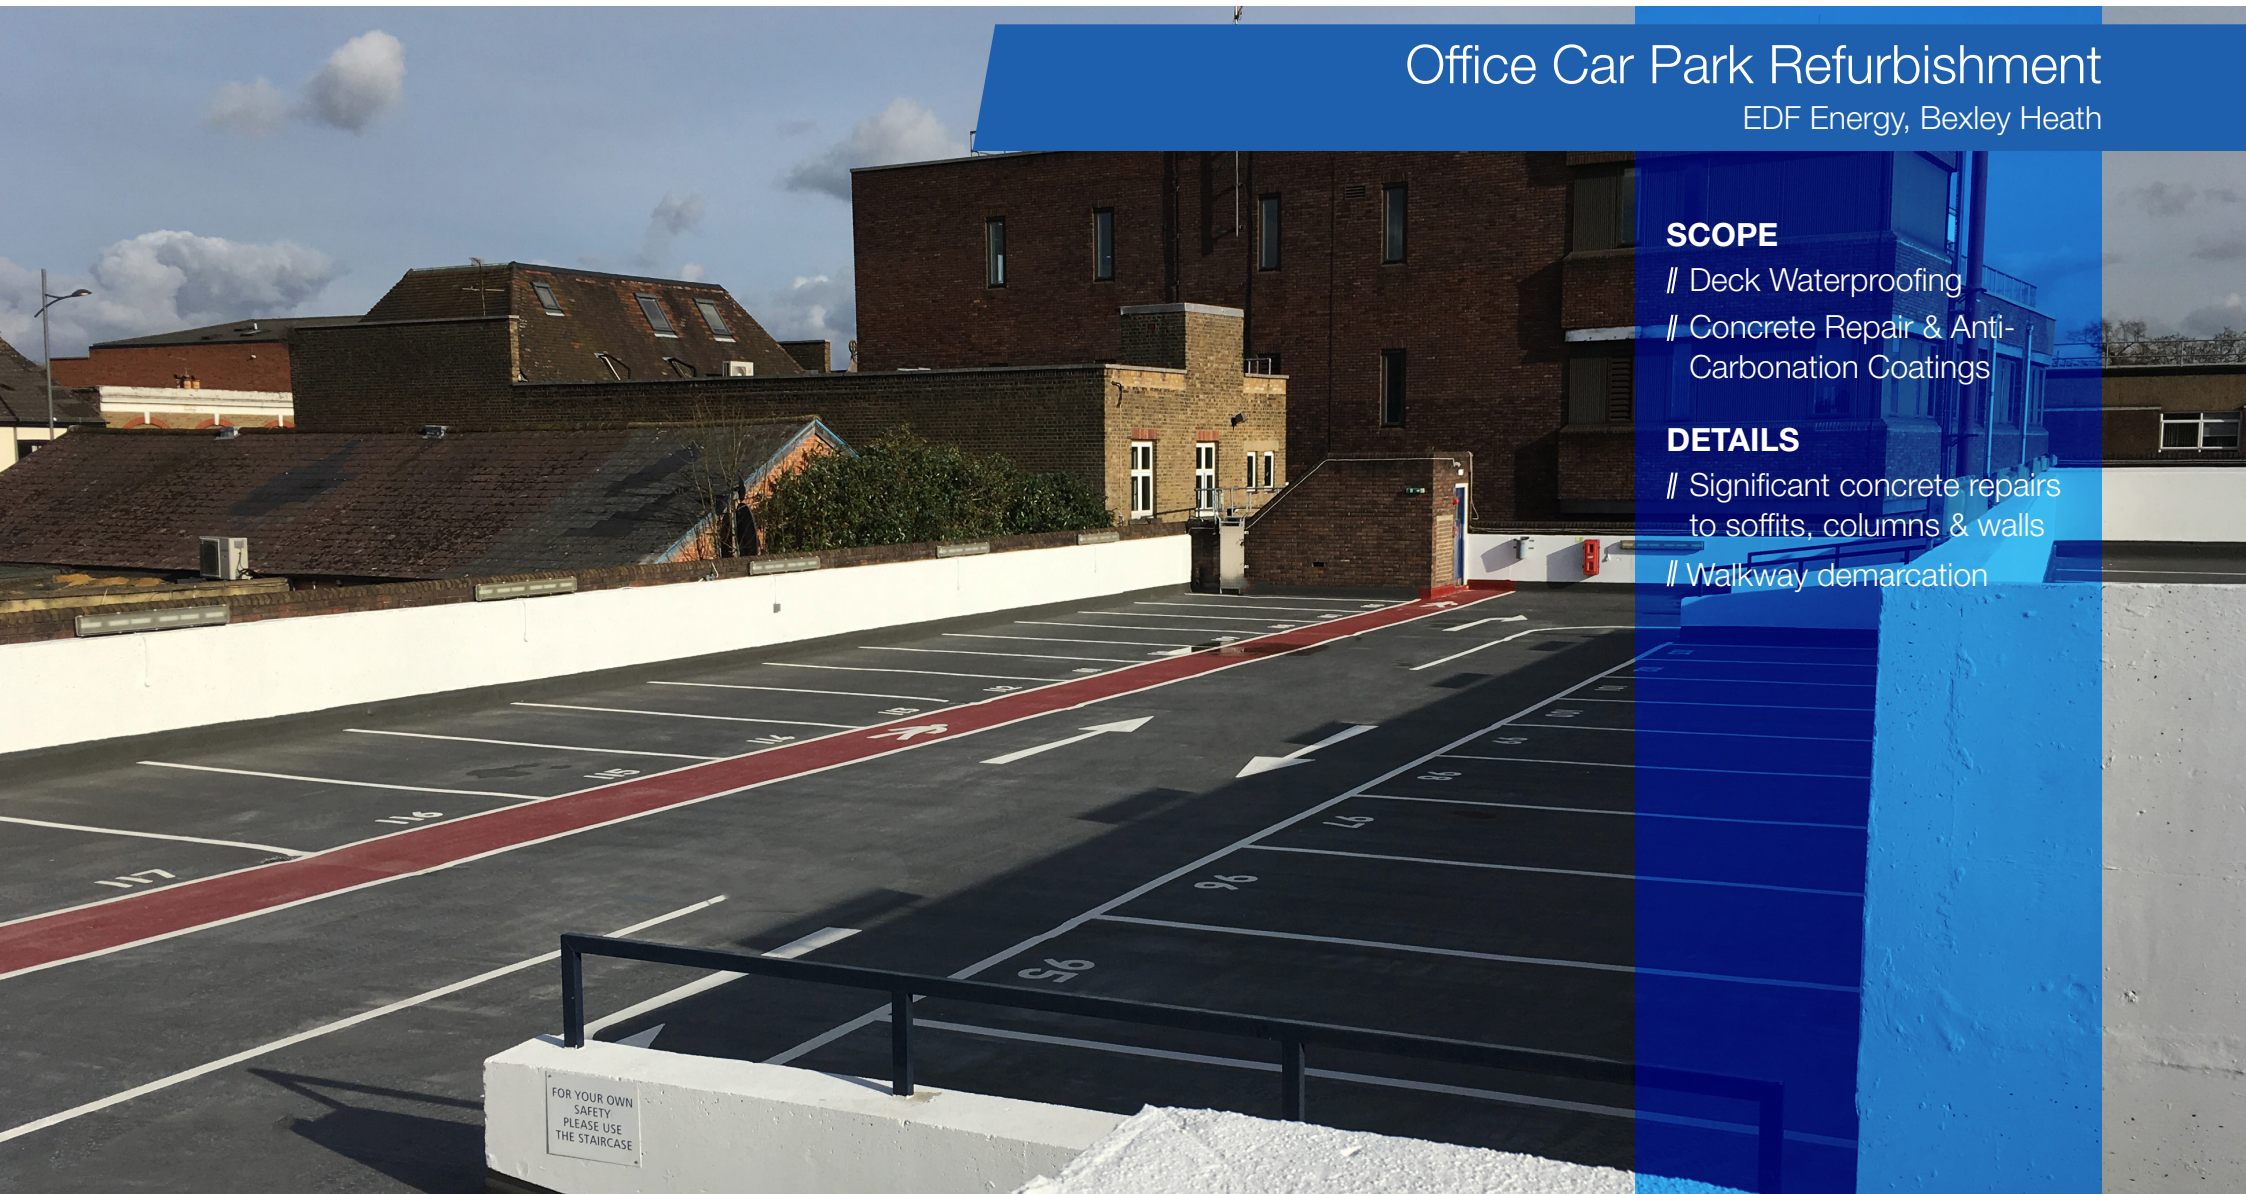
Before: Dark & Unwelcoming Environment

The scope of this project was to fully refurbish the North, South, Staff and Visitor car parks as part of an ambitious 9-week programme.

Significant repairs had to be carried out all car parks following concrete damage caused by the long-term effects of both carbonation and chloride-induced corrosion. Sika's Monotop concrete repair system was utilised for concrete

repairs to all soffits, beams, columns and walls. These were also protected with Sikagard anti-carbonation coatings.

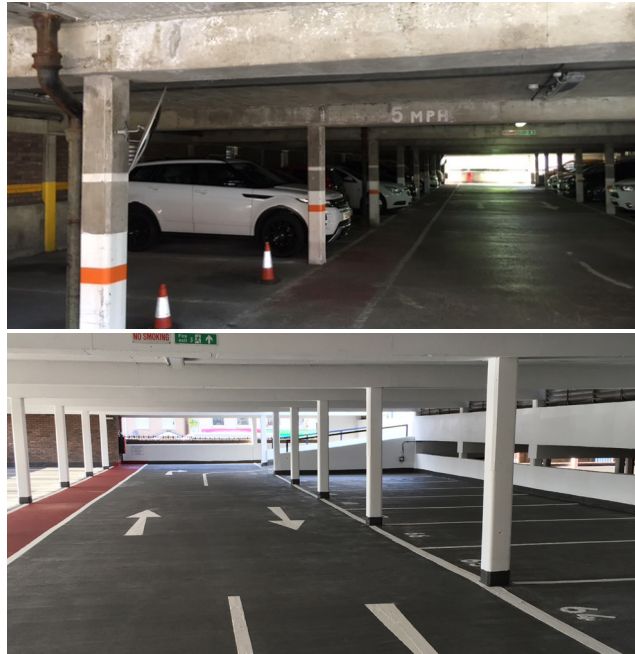
After: Light & Bright Interior Improvements

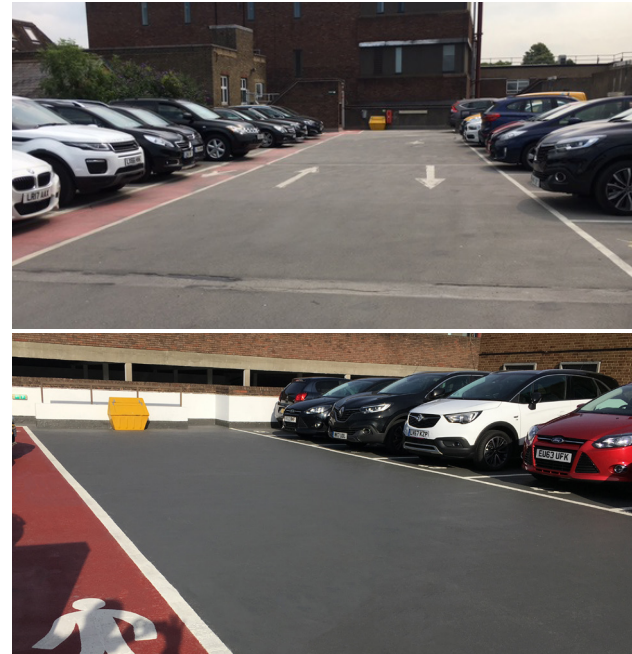
Before: Failed Existing System

After: Fully Protected Decking

Circa 1,810m² of parking decks were completely re-waterproofed with Sika's RB58 car park decking waterproofing system. This rapid-curing system incorporates Sika Reemat Premium encapsulated within the resin layer to ensure full crack-bridging ability and

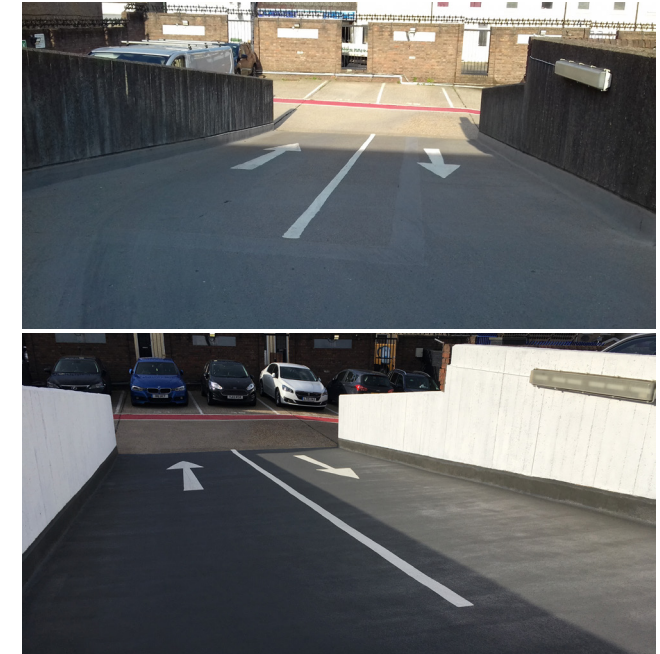
Progress: Ramps Halfway Through Refurbishment

After: Fully Protected Ramps

durability when applied directly onto asphalt deck areas. This system was applied in contrasting colours of mid-grey for both the traffic aisles and parking bays with bright red to highlight the pedestrian walkways for increased safety.
