Case Study // Car Parks

Client | Q-Park Role | Principal Contractor

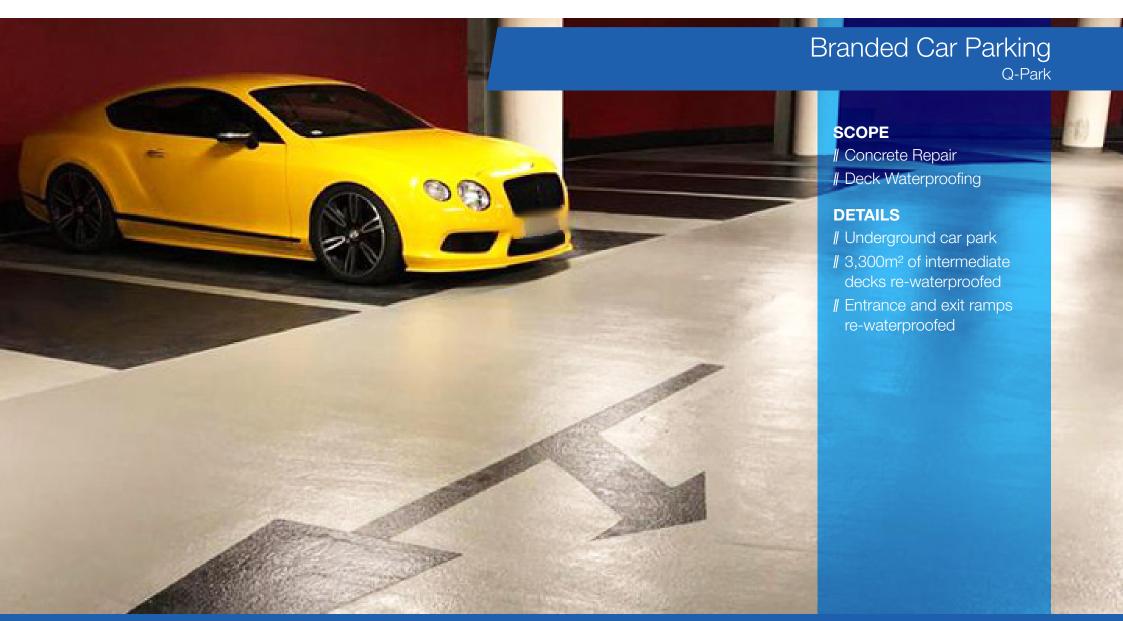
Before: Off-street Access to Basement Car Park

After: Light & Bright Welcome to Car Park

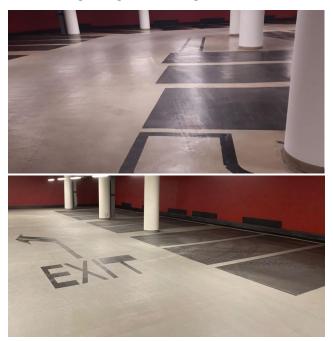
Before: Existing Coatings Tired & Damaged

Cemplas were appointed as Principal Contractor to transform basement level 2 of the car park. Existing coatings were removed by planing and captive blasting with minor concrete repairs carried out.

Tremco's Deckshield SF system was installed throughout with parking bays and instructions built into the system. The entrance and exit ramp was also renovated but using
