## Case Study Waterproofing

#### The scope of this refurbishment was to design and install the below-ground waterproofing works to the illustrious Victoria Palace Theatre in London's West End.

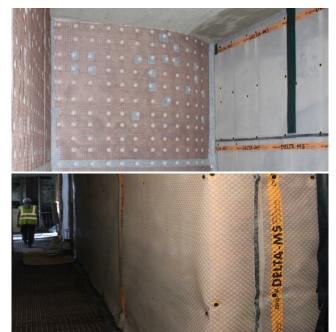
In Progress: Cavity Drainage system to Walls

Delta cavity membranes were applied to the walls and floors across a range of different areas including the comms and plant rooms as well as the Orchestra Pit and below the stage itself. Sika 1 waterproof render was also applied to a range of areas including WC's, bars and the Client | 8Build Ltd Role | Specialist Sub-Contractor

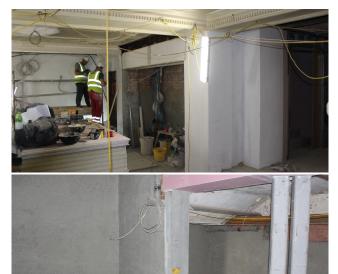
In Progress: Slka 1 Render & Screed

theatre's main boiler room. RIW's Bituthene 4000 was applied to a range of areas to complement the overall waterproofing design.
